## 1. INTRODUCTION

On February 19, 2015 Build Change, represented by Juan Caballero, Lizzie Blaisdell and Hector Romero Toro, visited six schools in the districts of San Marcos (four) and Quetzaltenango (two), Guatemala. See Figure 1 for the location of the two cities in Guatemala. These schools had been damaged by either or both of the recent earthquakes in the area; some had or were receiving some form of repair while others still remain in their post-earthquake damaged state. The intent was not to perform detailed evaluations of each school during the visit, but instead to get a better understanding of the schools each municipality may need technical assistance with, what their construction styles are and what the potential deficiencies may be.

This report summarizes the observations made at each of the visited schools, identified potential deficiencies as well as possible retrofit strategies.

**3. SCHOOL OBSERVATIONS**  
**3.1 INSTITUTO NACIONAL DE EDUCACION BASICA EXPERIMENTAL**  
**“MARIA CRISTINA BARRIOS”**

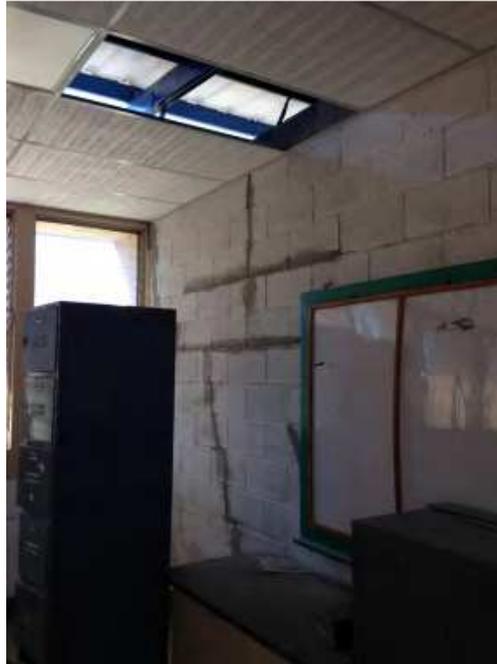
In several buildings, the existing walls showed signs of shear cracking in the earthquakes. In most cases, these cracks had been repaired (Figure 4) or the wall had been rebuilt. Some buildings had experienced roof failures, and were in various states of repair (Figure 5).

Figure 4 – Repaired wall cracks

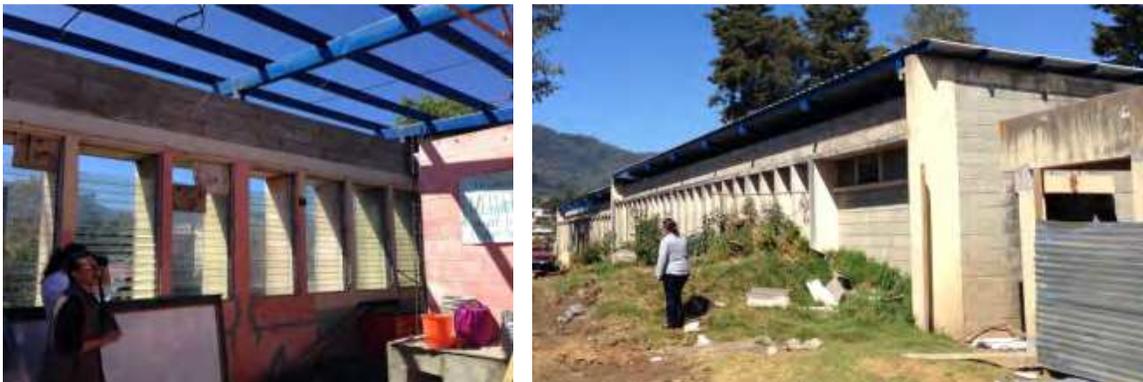
- Lack of longitudinal shear walls – The longitudinal classroom walls consisted primarily of window openings which reduces the lateral strength and stiffness of the building in the longitudinal direction (Figures 5 and 6). In some buildings a solid wall panel was provided at the end of the longitudinal wall elevation (Figure 3) but in other buildings it was not.

Figure 5 - Typical Longitudinal Wall and Elevation at the Classrooms

- Infill some windows and add confining elements as needed to create more solid wall panels in weak direction.
- Provide a upper ring beam adequate for spanning between cross walls
- Remove short solid panel above door opening (solid wall panel infilled elsewhere)
- Supplement wall strengths as needed (double walls, reinforced concrete overlay)
- Demolish heavy concrete frame canopy. Replace with a light weight structure if necessary.

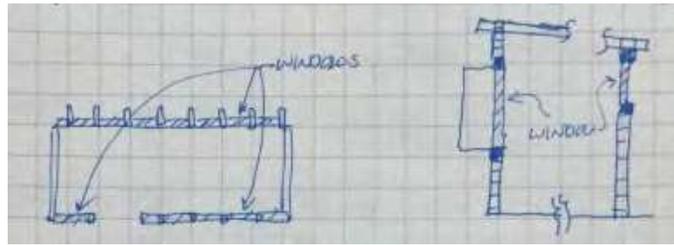
Figure 6 – Sketch of typical classroom floor plan and section

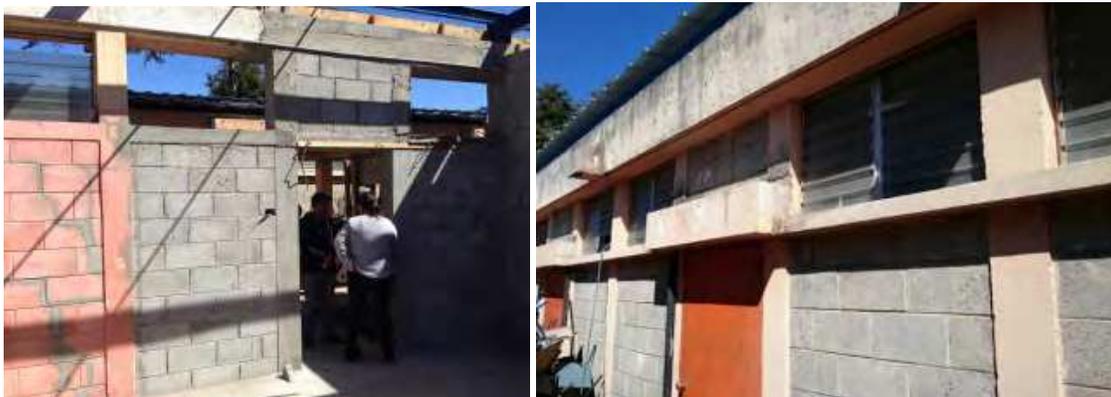
- Short column/pier condition – Typically one longitudinal elevation had a high row of short windows. These windows were continuous, with period vertical posts and with only one solid panel, located above the door. (Figure 7) This solid panel was typically where the damage was concentrated. As the most rigid load path from the roof to the solid wall below the windows, it attracted higher earthquake forces and failed. These were being repaired in several classrooms to the pre-damage state and so failure in a similar way would be expected in future earthquakes. These seem particularly dangerous as they are located over the exit – which is exactly where students would be heading in the event of an earthquake.

Figure 7 – Repaired short pier above door (left) and existing pier (right)

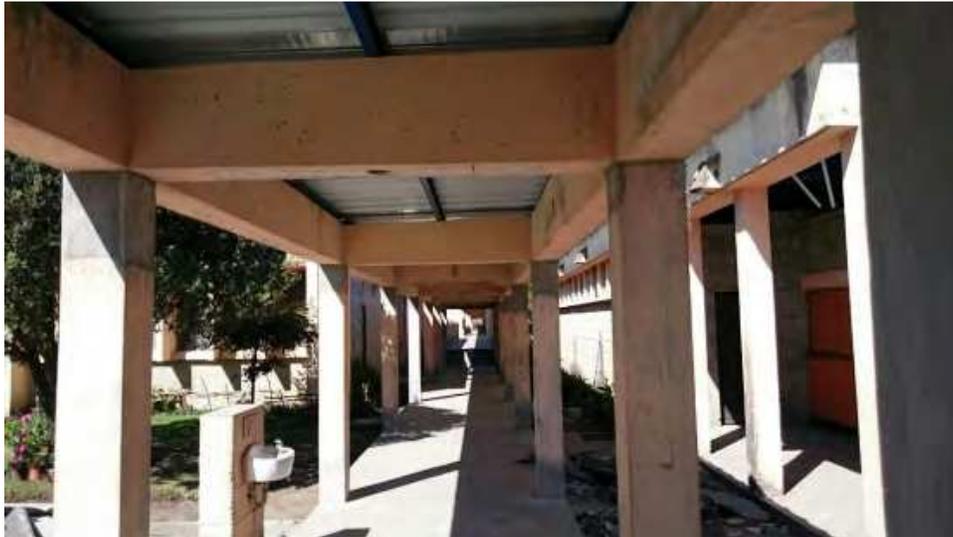
- Walkway canopy - There are structurally independent walkway canopy structures composed of reinforced concrete moment frames (Figure 8). These structures failed at the top and bottom of the columns. Repairs have been made, but strengthening or the addition of bracing to prevent future failure in the same way has not been performed, so it is reasonable to expect similar or likely worse, performance in future earthquakes.

Figure 8 – Repaired concrete frame canopy structure

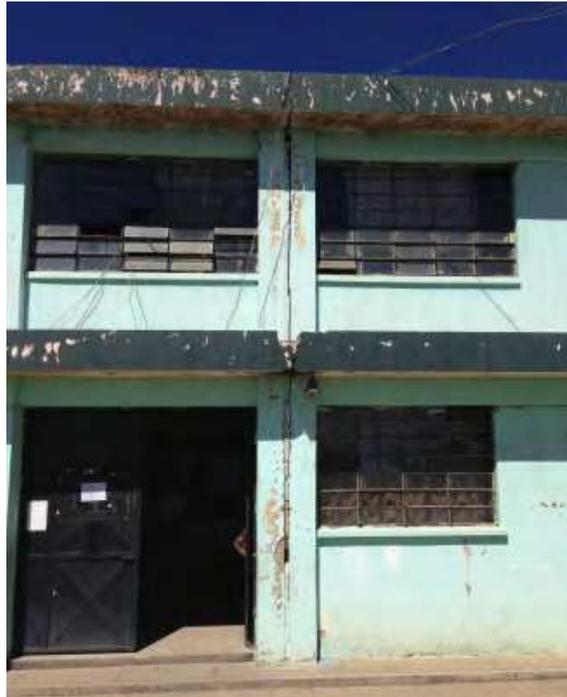
Figure 11 – Seismic joint between concrete frame buildings – mortar-covered & foam-filled

- Unconfined wall panels – With the joint material separating the infill from the frame, the panel is largely disconnected and unconfined. Unconfined wall panels can more easily suffer out-of-plane failures.
- Inadequate seismic joint – The small joint between buildings could result in pounding damage in future earthquakes. However, given that the floor and roof slabs align, significant damage due to this pounding, such as a collapse, may be less likely.

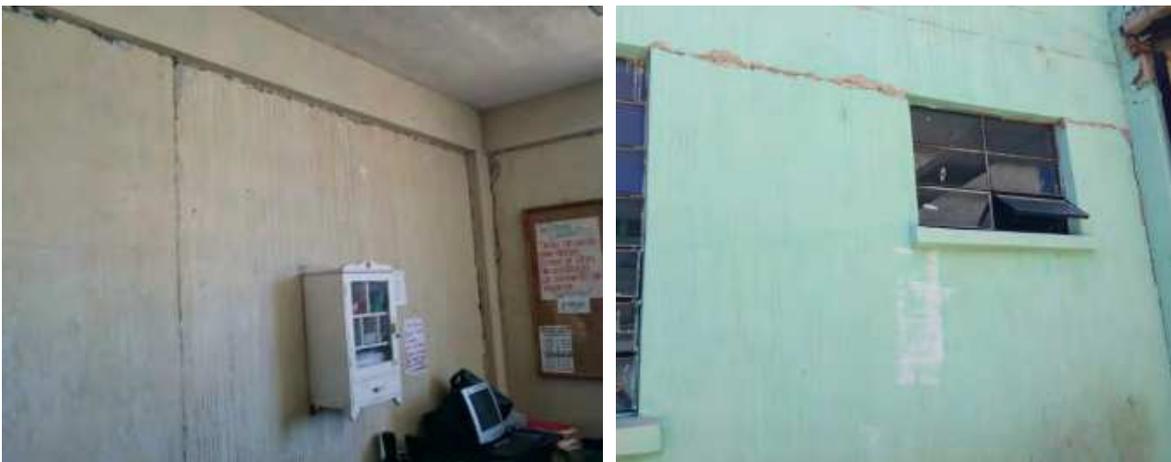
The confined masonry building had been repaired and appeared to have thicker wall piers between windows. The reinforced concrete frame buildings were still in their damaged state. According to the school principal, the first earthquake caused cracking at the infill panel edges (Figure 12) and the subsequent earthquake led to some cracking in beams and columns (Figure 13). In some cases, the cracking around the panel edges is significant and could lead to out-of-plane failures of the wall panel in future shaking.

Figure 12 – Cracking around infill panel perimeter at interface with concrete frame at interior (left) and exterior (right)

- Replace infills strategically to create solid shear wall panels.
- Connect or confine all masonry infills.
- Provide reinforced concrete overlays to the shear walls as needed for increased strength.
- Effectively repair damaged beams or columns.

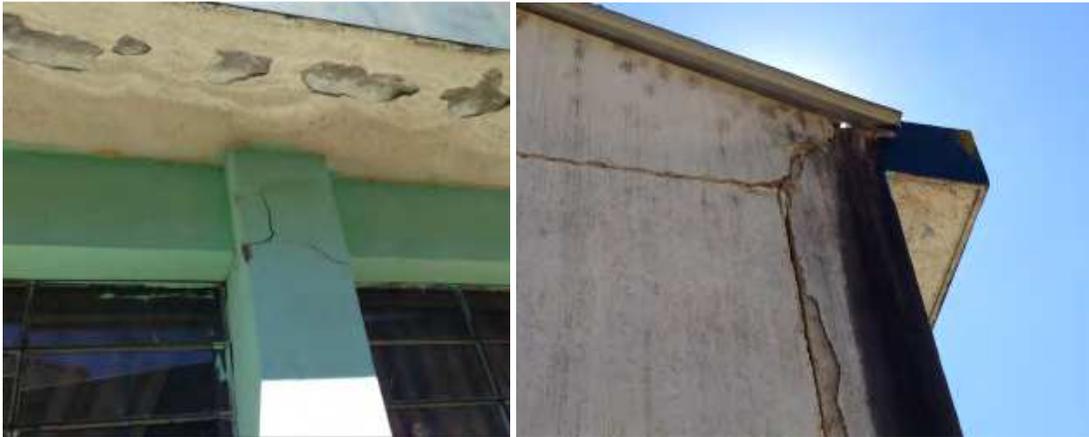
Figure 13 – Column-to-beam joint damage

- Non-ductile concrete frame - Due to the age of the concrete moment frame structure, it is likely that ductile frame detailing specified in more recent building codes is not present. In the absence of the wall panels to help resist lateral loads, the frame would likely have significant damage and drift – potentially failure.

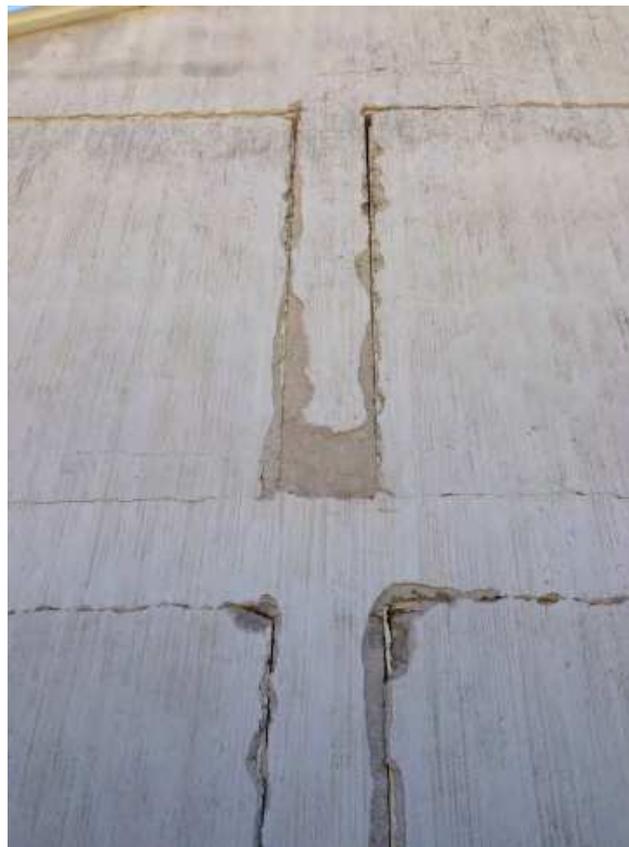
Figure 14 – Significant panel edge cracking

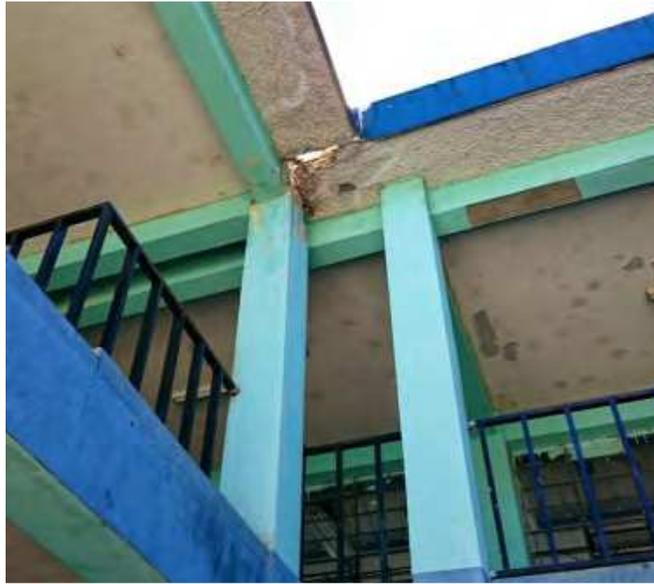
Some pounding damage was observed due to the interaction of the buildings at the seismic joints (Figure 15). The pounding appeared to cause only localized damage at the building roof and slab.

Figure 15 – Evidence of pounding

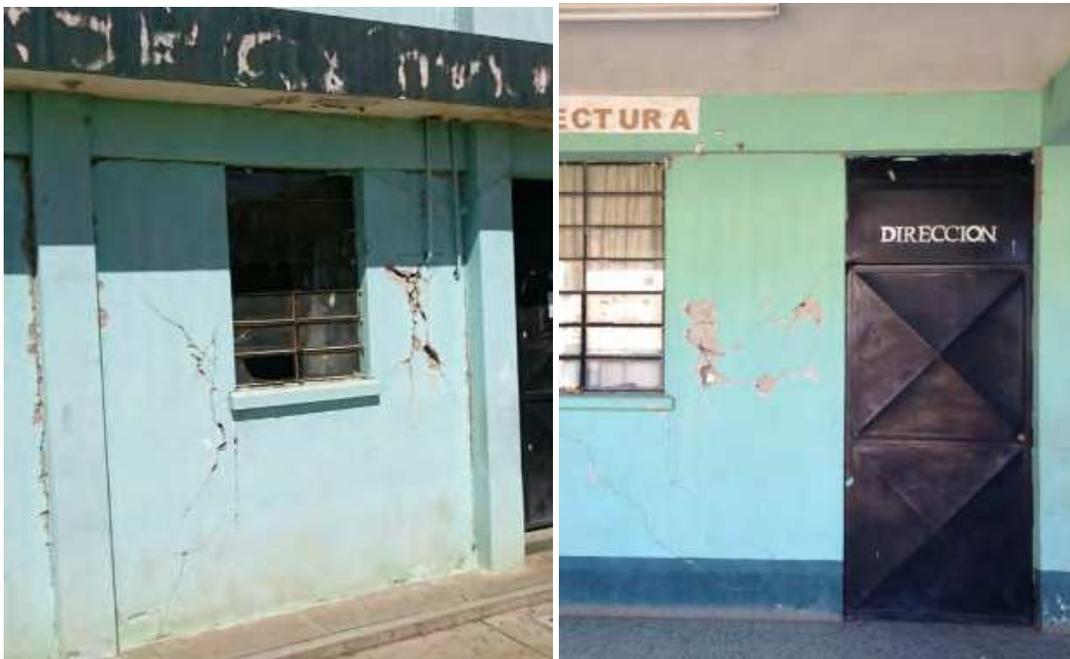
Shear cracking of several wall panels was also observed (Figure 16). This implies that, despite the foam interface between the masonry wall panels and frame, the panels were engaged to resist lateral forces during the earthquake.

Figure 16 – Shear cracking of infill

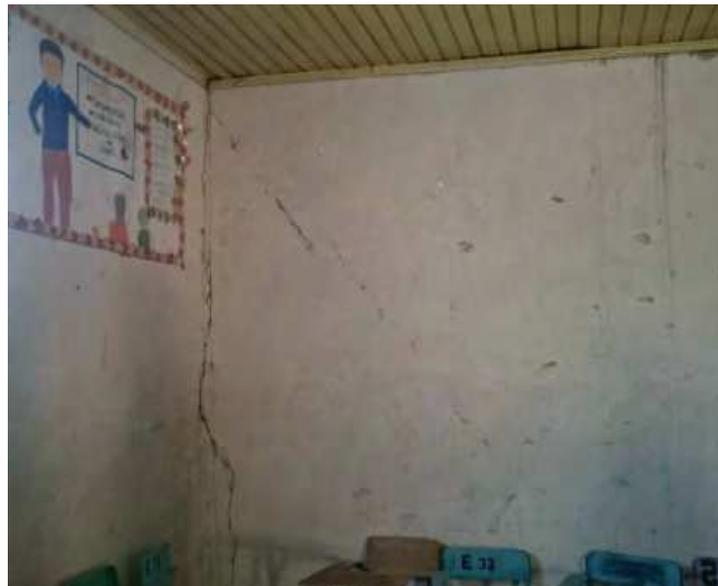
The two-story building was constructed after the earthquake and therefore had no damage. The one-story structures had some in-plane (Figure 20) cracking and out-of-plane failures (Figure 21) of the unreinforced masonry walls. The three-story structure was more heavily damaged and only partially repaired. There was evidence of wall failures in shear (Figure 22), short column failures (Figure 23) (which had been repaired by adding a new column next to the failed column (Figure 24)), and residual out-of-plane wall movement (Figure 25).

Figure 20 – In-place cracking of URM

- Demolish leaning walls
- Replace or repair damaged walls and strengthen as needed
- Infill some windows along the longitudinal elevations to create solid shear wall panels
- Install a ring beam sufficient to brace the walls out-of-plane at the light weight roofs
- Thicken slender walls with a reinforced concrete overlay (or rebuild with wider blocks)
- Demolish cantilevered third floor walls and rebuild aligned with supporting walls below
- Tie intersecting walls of URM buildings together with added vertical confining ties
- Increase the ductility of URM walls by adding reinforced concrete elements at the doors and windows.

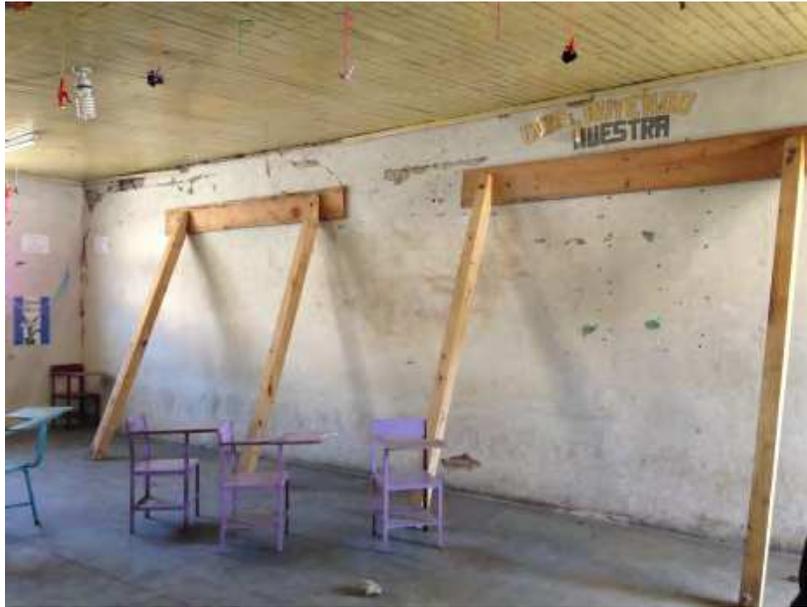
Figure 21 – Unreinforced masonry wall out-of-plane failure

- Excessive height-to-thickness ratios – The auditorium walls, the front cantilevered perimeter wall and the unreinforced/unconfined masonry walls have excessive height-to-thickness ratios, which mean they are slender and susceptible to out-of-plane failure or collapse.

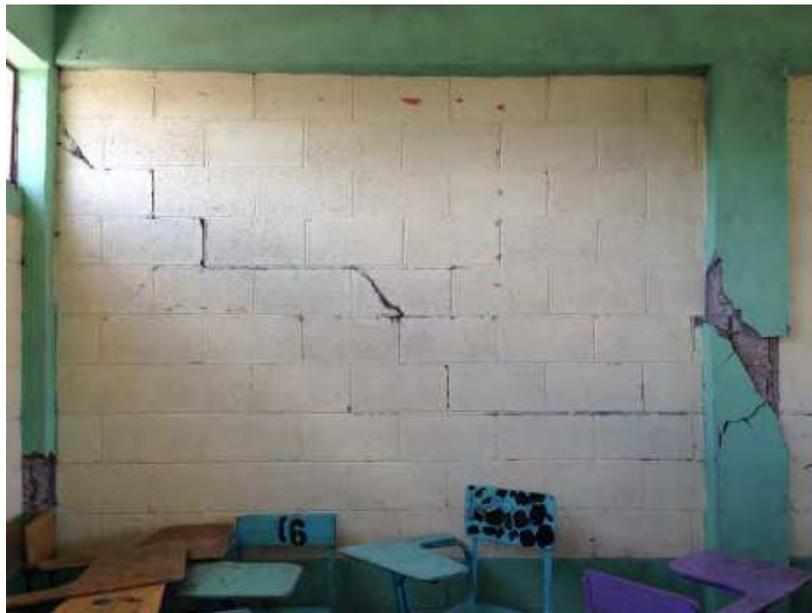
Figure 22 – In-plane shear failure (masonry and column)

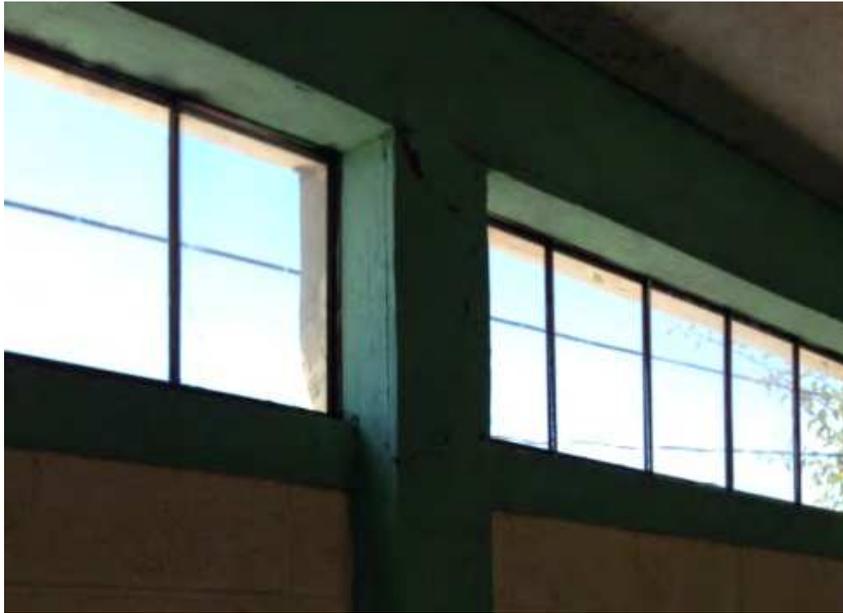
Figure 23 – Short column shear failure damage

- Short column conditions – The short columns at the windows along the longitudinal elevations are prone to shear failure in an earthquake, unless a stiffer lateral load path – such as a shear wall is provided – in series.

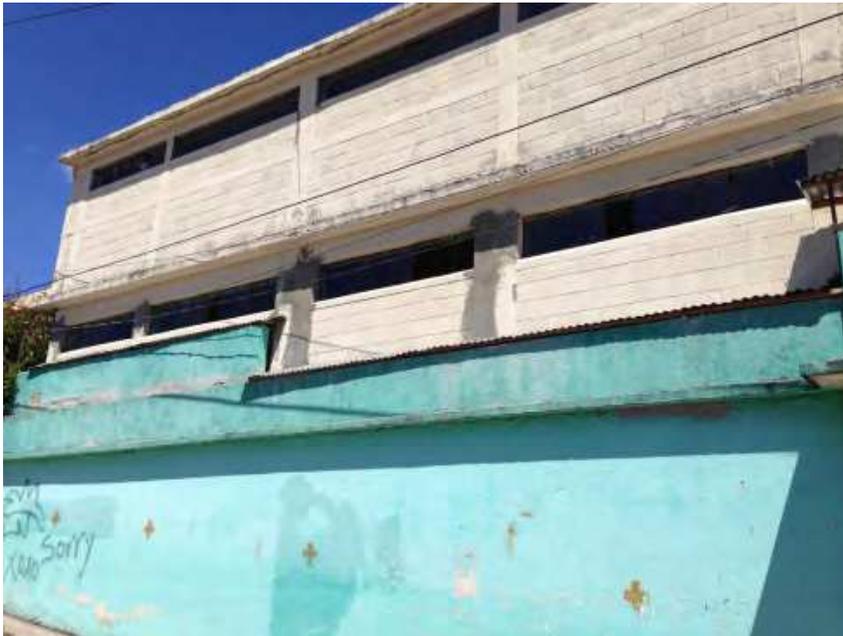
Figure 24 – Short column repairs (double columns installed)

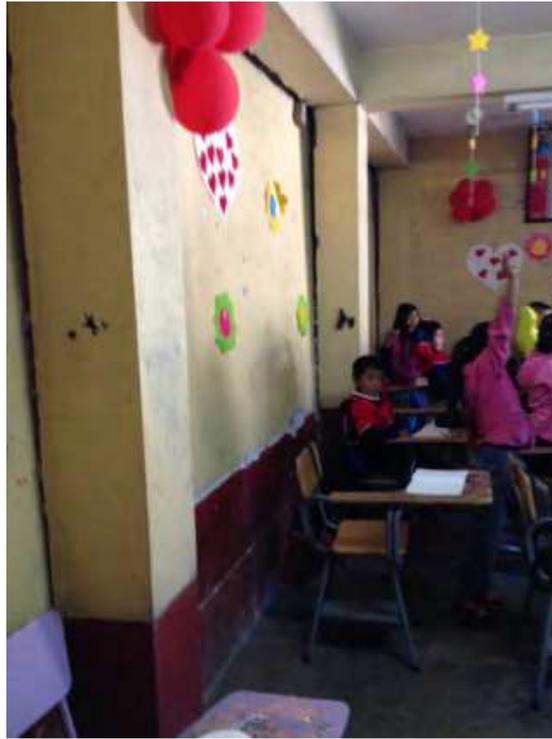
Figure 25 – Out-of-plane wall movement and separation from frame

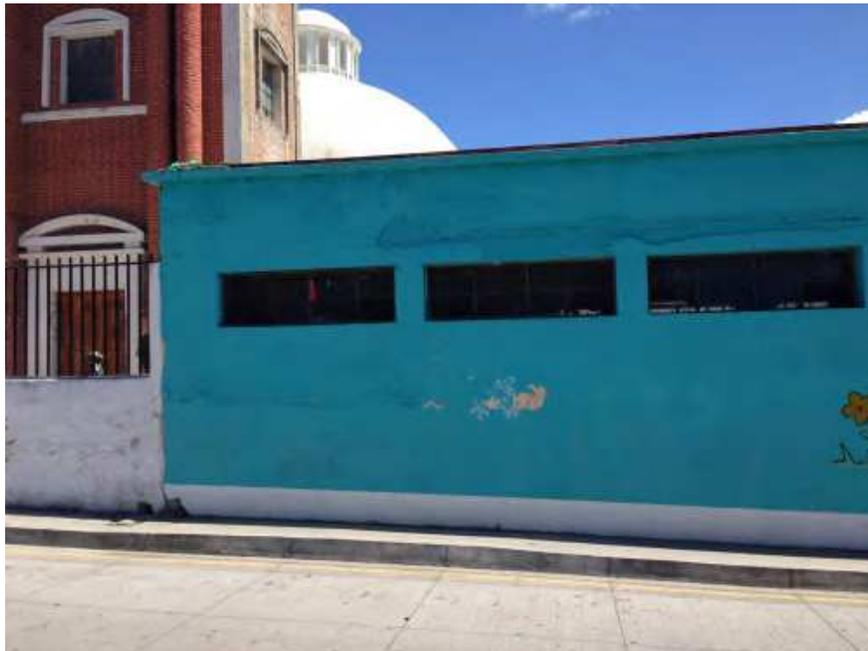
There was evidence of prior cracking where the roof met the exterior wall (Figure 29), cracking at columns along the window sill level (Figure 30) – particularly on the courtyard side where there were few walls and mostly windows, cracking at the top of walls (Figure 31), and some shear cracking in walls (Figure 32).

Figure 29 – Evidence of horizontal cracking at wall-roof intersection

- Replace or repair damaged walls and strengthen as needed
- Infill some windows along the courtyard longitudinal elevations to create solid shear wall panels
- Install a ring beam sufficient to brace the walls out-of-plane at the light weight roofs
- Tie intersecting walls of URM buildings together with added vertical confining ties where confining elements are missing

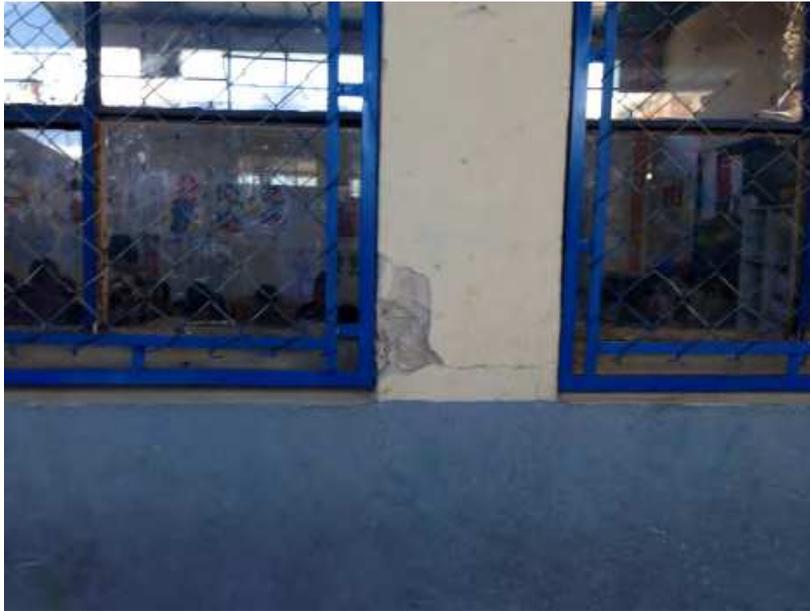
Figure 30 – Cracking at column base at window sill

- Lack of shear walls in longitudinal direction at courtyard elevations – At the courtyard facing elevations, the longitudinal walls had very few solid wall panels and mostly windows. This reduces the lateral strength and stiffness of the building in the longitudinal direction.

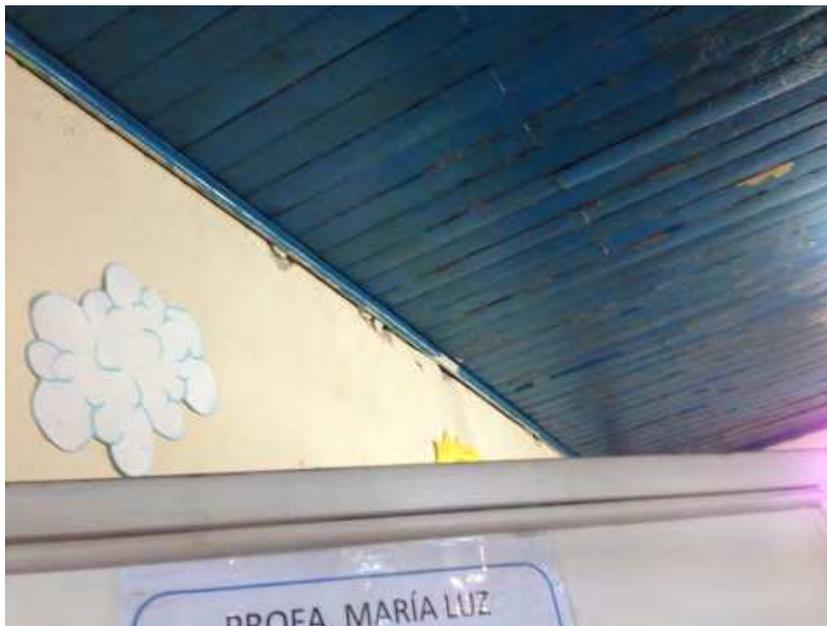
Figure 31 – Cracking at the top of walls (where wall and ceiling pulled apart)

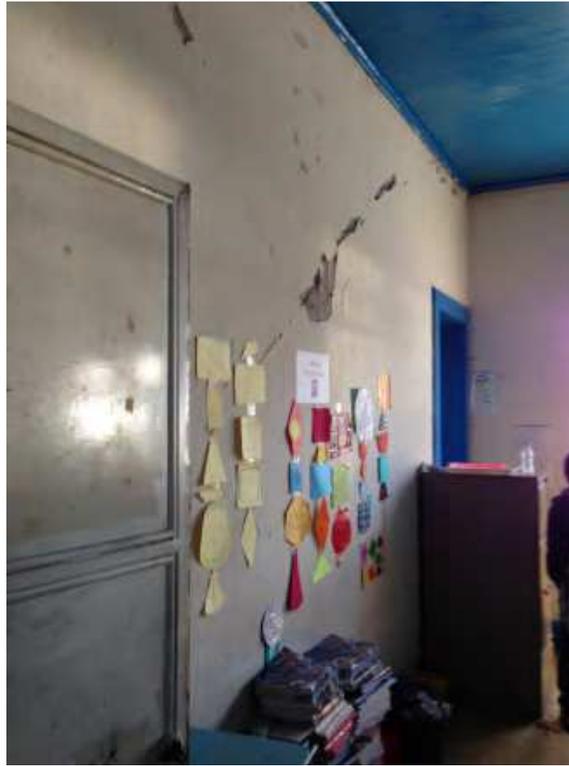
Figure 32 – Shear cracking in wall panels

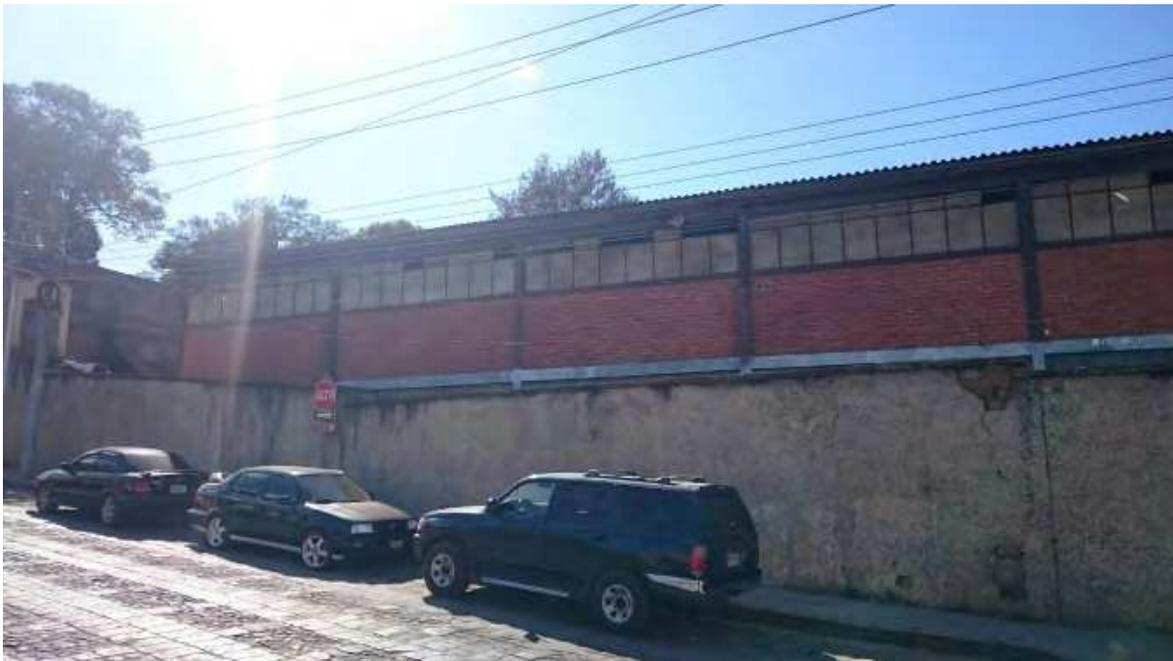
Figure 33 – Front elevation

- Lack of longitudinal walls – The longitudinal walls were only half-height to permit windows at the upper half of the walls. This reduces the lateral strength and stiffness of the building in the longitudinal direction.
- Short columns - The short columns at the windows along the longitudinal elevations are prone to shear failure in an earthquake, unless a stiffer lateral load path – such as a shear wall is provided – in series
- Torsion – Depending on the configuration of the lower half of the building, it is possible that the sloping site could cause stiffness irregularities, leading to torsion of the structure.

- Strengthen existing walls as needed.
- Infill some windows along the longitudinal elevations to create solid shear wall panels.
- Stiffen and strengthen the downhill lateral system elements to reduce effects of torsion.

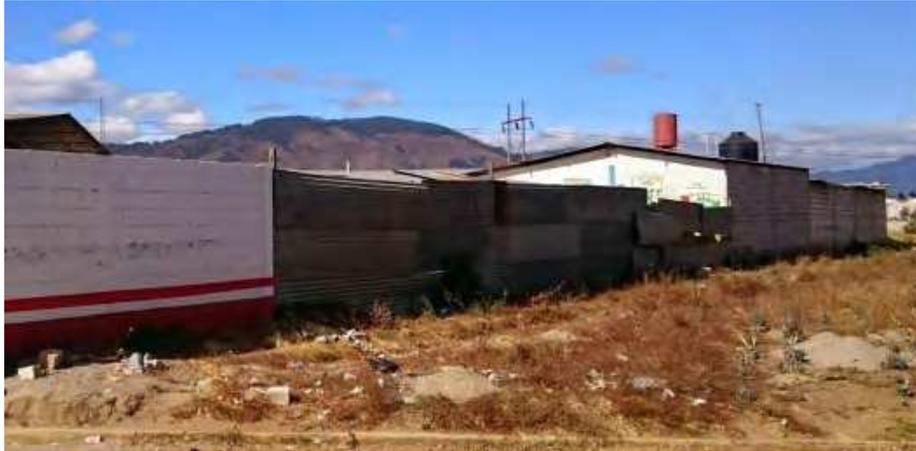
Portions of the cantilevered perimeter wall had collapsed and were replaced by metal sheeting (Figure 36). One building had suffered damage to the windows. The school infilled these windows with masonry in order to close the damaged windows and strengthen the building (Figure 37).

Figure 36 – Temporary perimeter wall

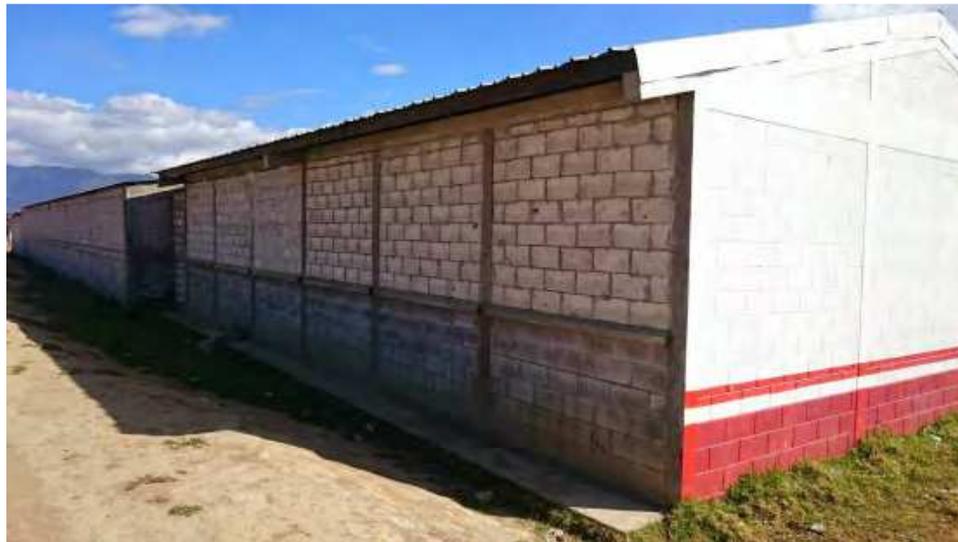
Figure 37 – Masonry infill at damaged classroom windows

- Strengthen walls as needed
- Infill some windows along the longitudinal elevations to create solid shear wall panels
- Dry pack grout at perimeter of recently infilled windows to ensure confinement of masonry panels.
- Add bracing to top of wall at diaphragm level to decrease out-of-plane wall deflections

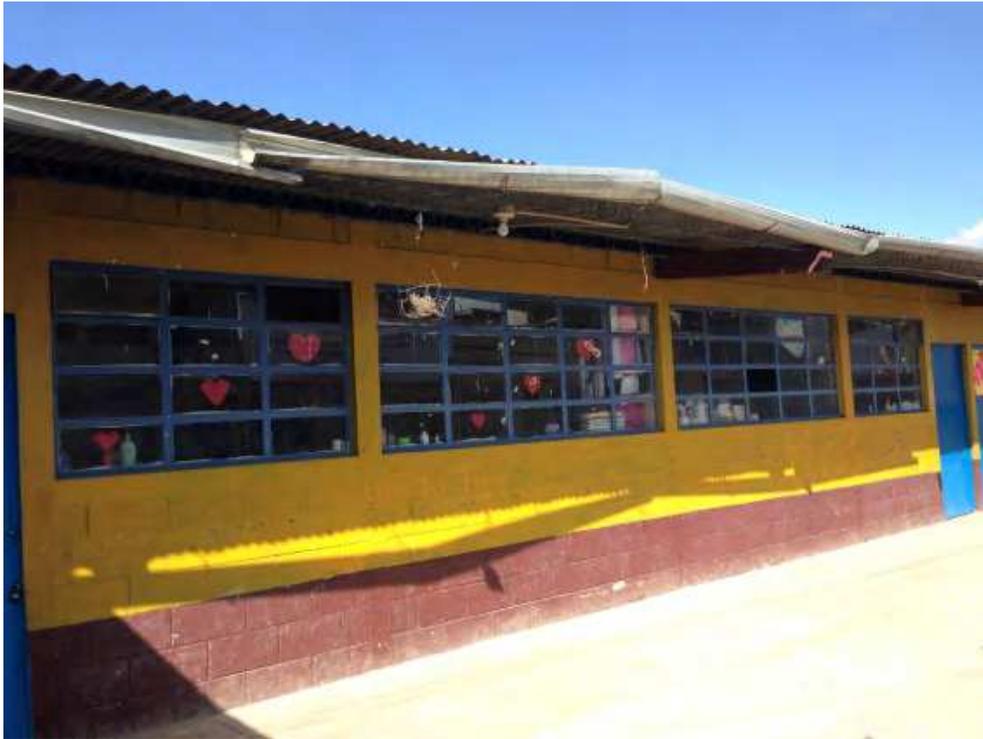
- Lack of longitudinal walls - The longitudinal walls facing the interior of the site were composed of mostly windows and not wall panels (Figure 38). This reduces the lateral strength and stiffness of the building in the longitudinal direction.

Figure 38 – Interior longitudinal wall elevation
