**Build Change, AARGI, and EERI
Earthquake Reconnaissance Report:
M6.5 Pidie Jaya Earthquake,
Aceh, Indonesia on December 7, 2016**

Lizzie Blaisdell Collins (*Build Change*), Elwahyudi (*Build Change*), Edwin Lim, Mediatrich Triani Novianingsih (*Build Change*), Muhammad Riyansyah (*AARGI*), and Hartanto Wibowo (*Iowa State University*)

May 2017

A product of the EERI Learning From Earthquakes Program

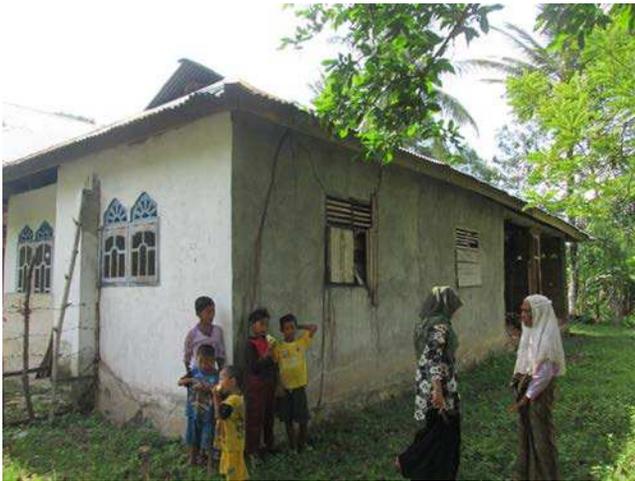
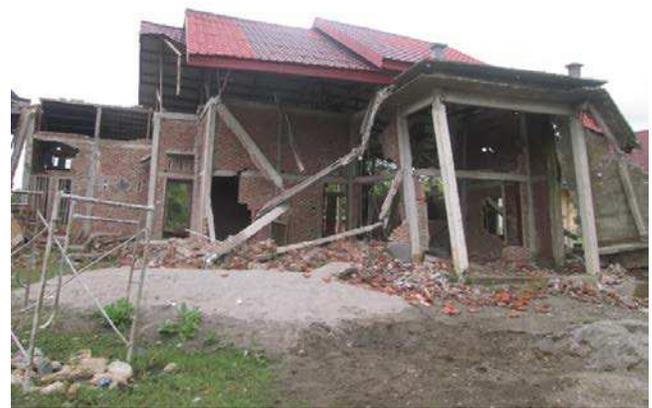
Confined or partially confined masonry houses and schools suffered a range of structural damage from minimal to collapse (Figure 3 and Figure 4). One of the more commonly observed damage for houses was out-of-plane wall failure due to failure of very tall or very long and slender walls (3.5-4 m high, 10 cm thick, with h/t ratio of 35 to 40) or failure of the upper ring beams which were not sized or reinforced with enough capacity to span the longer distances present (either along the span or at the joint). In some cases, walls supporting the roof dead load appeared to perform better than walls which were more lightly loaded axially (Figure 5). One particular out-of-plane failure that was common in both houses and schools was collapse of the masonry gable wall. While many gable walls had vertical reinforced concrete elements extending up through them, this appeared to be ineffective in preventing collapse (Figure 6) since the vertical concrete elements were small and minimally reinforced, thus providing insignificant lateral stiffness to the panel.

Figure 3. (a) Confined masonry house with minimal damage and (b) with severe damage (photos: Build Change).

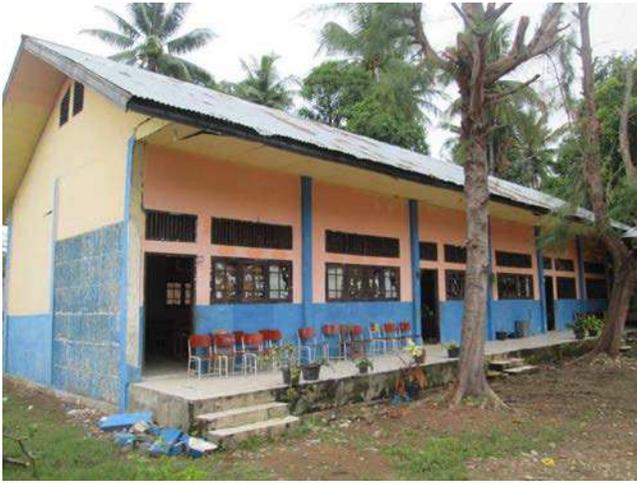
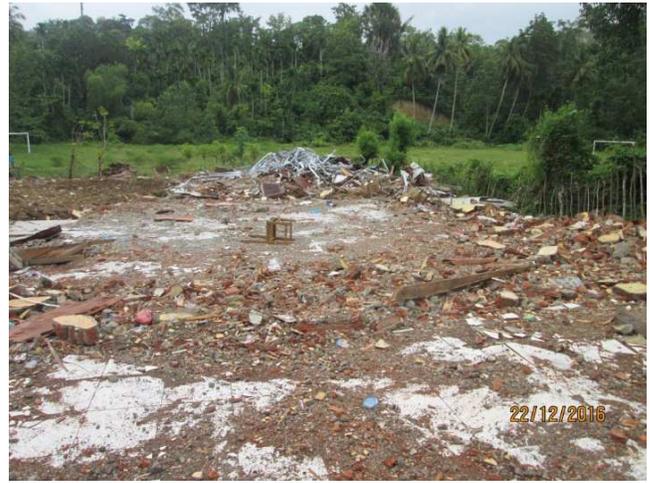
Figure 4. (a) Confined masonry school with minimal damage and (b) collapsed school (already cleared) (photos: Build Change).

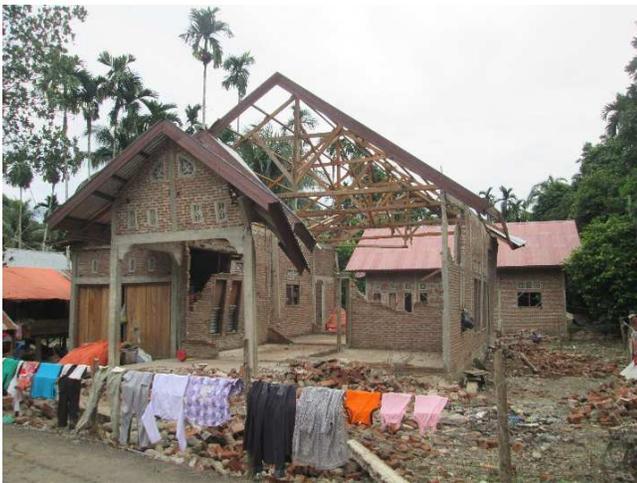
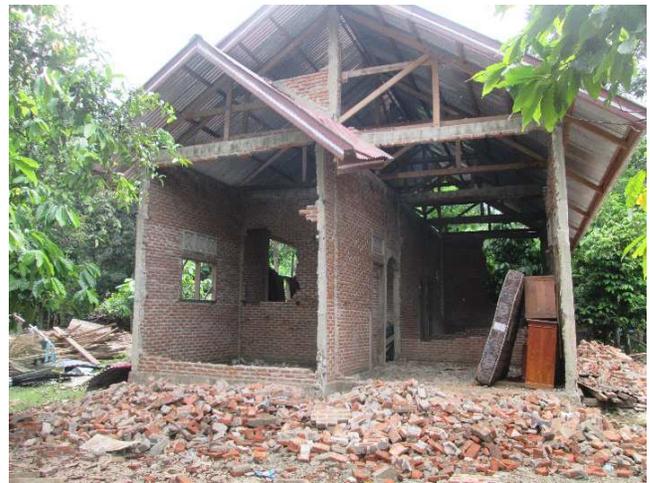
Figure 5. Confined masonry houses where walls supporting roof trusses performed better than other walls which suffered out-of-plane failure: (a) ring beam failure and (b) wall panel failure (photos: Build Change).

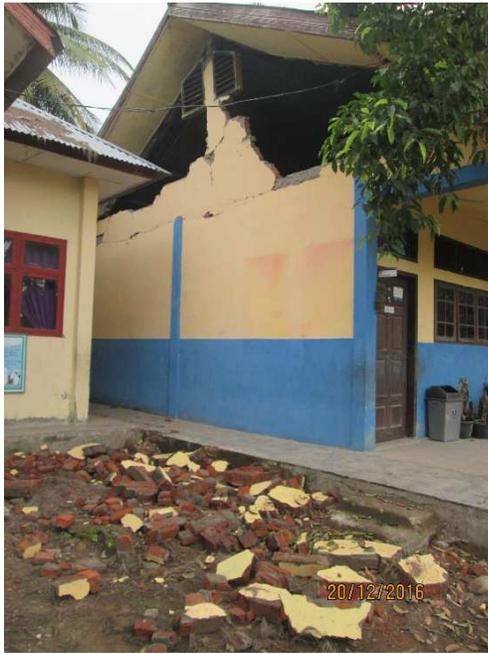
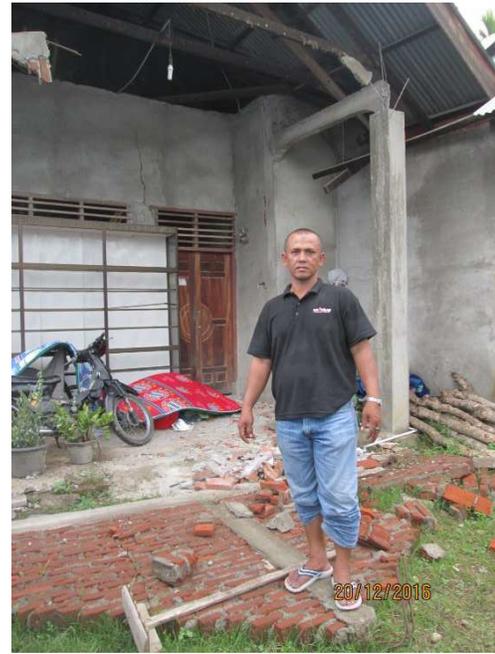
Figure 6. Collapsed masonry gable wall in (a) a school building and (b) a residence (photos: Build Change).

- Gable walls should be constructed of light materials.
- Although it is important for classrooms to have adequate windows and ventilation, it is also important that lateral-resisting elements, such as confined masonry shear wall panels be provided along the longitudinal sides of the classroom buildings.

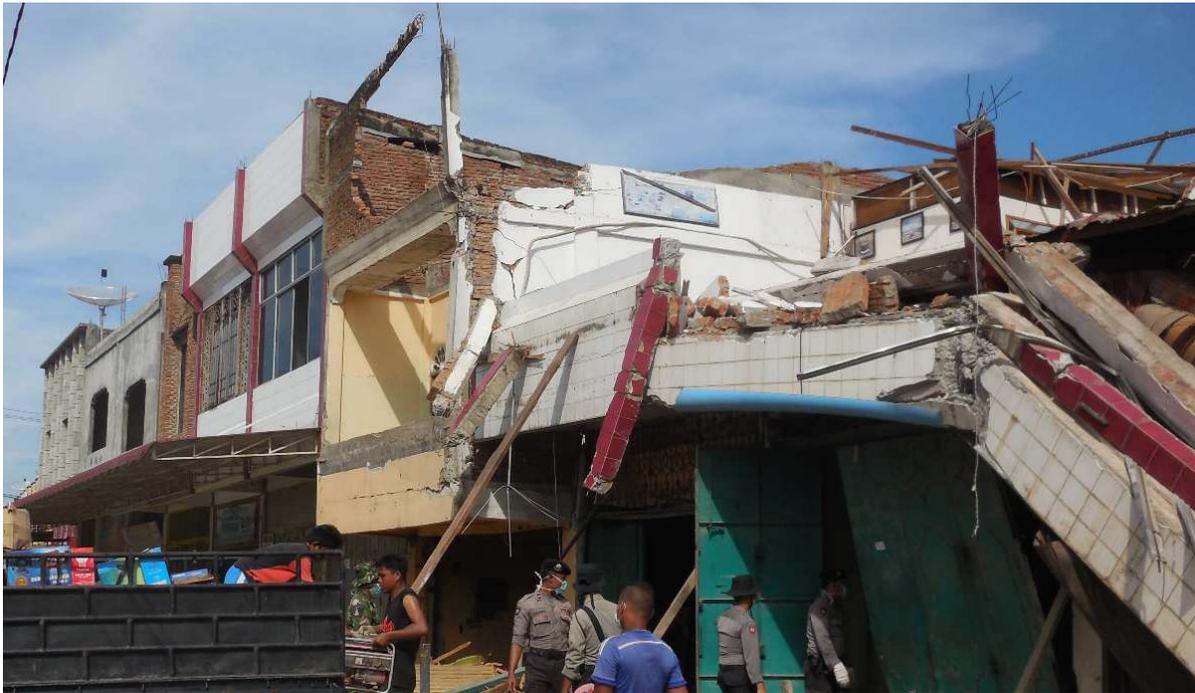
The practice of confined masonry construction is also common on low-rise shop-houses (typically 2-3 stories). This type of building is typically used for commercial purpose on the first story and residential purpose on the upper stories. Similar to the typical damage observed in other past earthquakes, the failure was attributed to soft-story mechanism of the first floor where wide opening exists as the main entrance for the commercial activity. Figure 7 shows the typical shop-houses in the affected area. BNPB reported that 78 shop-houses (BNPB, 2016) were damaged due to the earthquake. This number is relatively small compared to the number of damaged residential houses of 19,000 (BNPB, 2016). In the survey, the AARGI team observed that additional floor constructed above the existing building might have caused the damage because there were similar unmodified shop-houses located near the damaged ones that were unaffected by the earthquake. This additional floor changed the dynamic characteristics of the structures, and there was a great possibility that the existing structural components were not designed to carry that additional load (Figure 8).

Figure 8. Damages on the some shop-houses that have been modified from existing construction (photo: Muhammad Riyansyah).

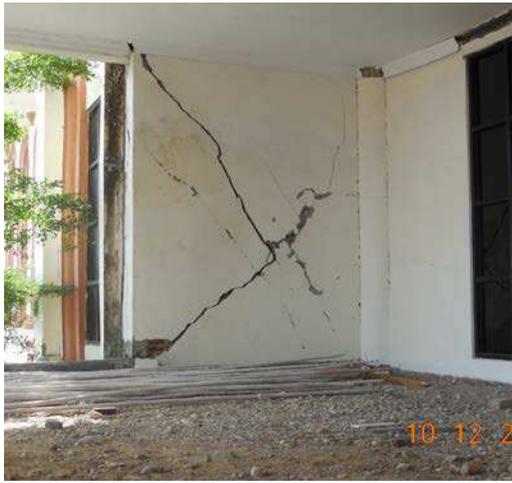
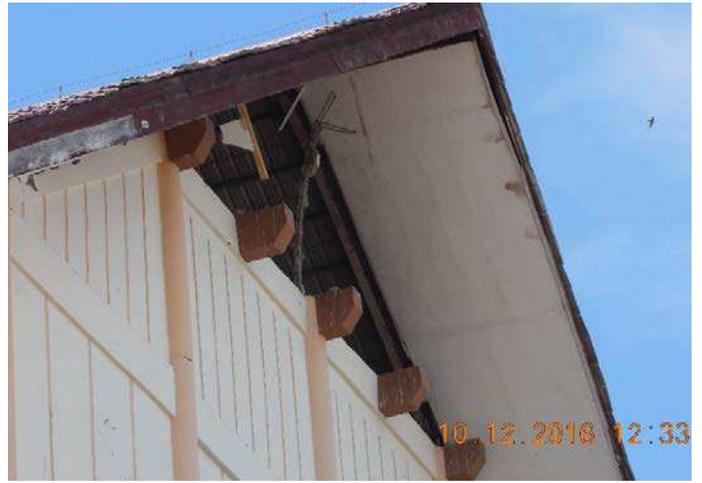
AARGI surveyed 8 government offices, a low-rise school building, and a mosque that were constructed using reinforced concrete and masonry infill. Most damage was characterized by failure of non-structural components, such as damage on the masonry infills, gable walls, and ceilings (Figure 9 and Figure 10). The damage on the ceilings may be caused by fallen debris from the gable wall or poor detailing of the ceiling framing system.

Figure 9. Damage on infill and gable wall of reinforced concrete building (photos: Muhammad Riyansyah).

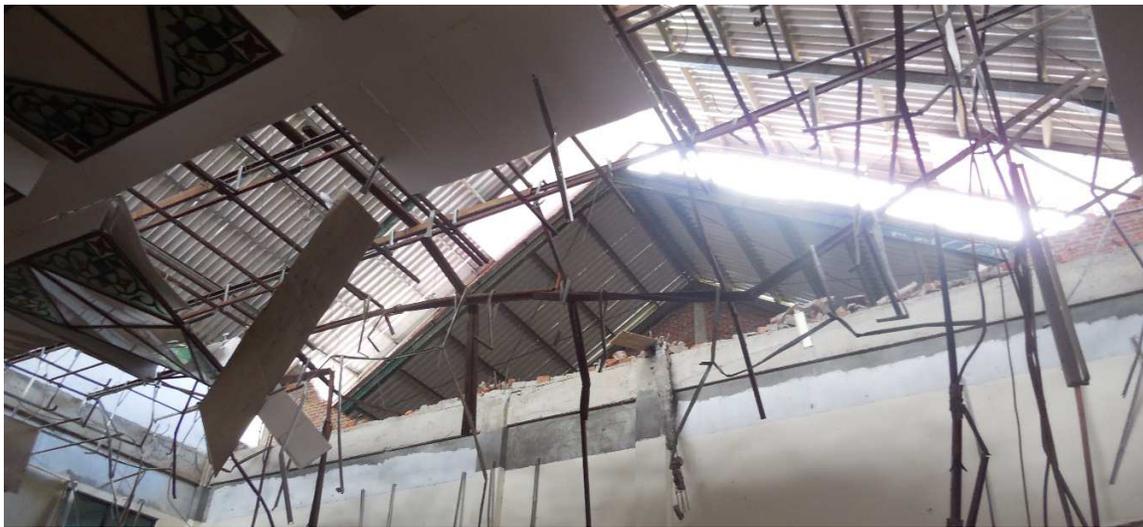
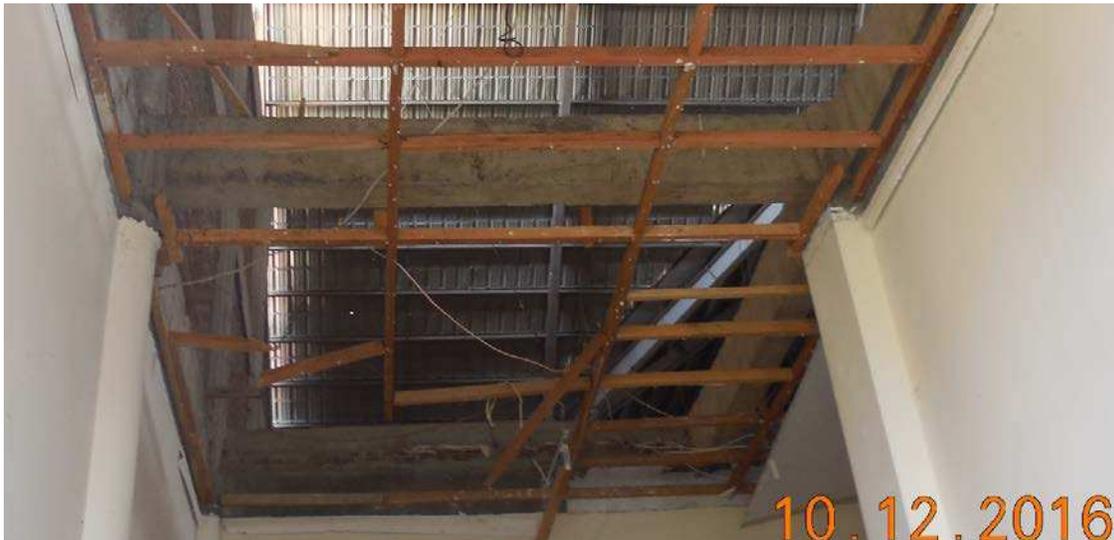
Figure 10. Damage to the same ceiling in both (a) and (b) (photos: Muhammad Riyansyah).

- Dropped ceilings should be supported and braced sufficiently to the building structure.

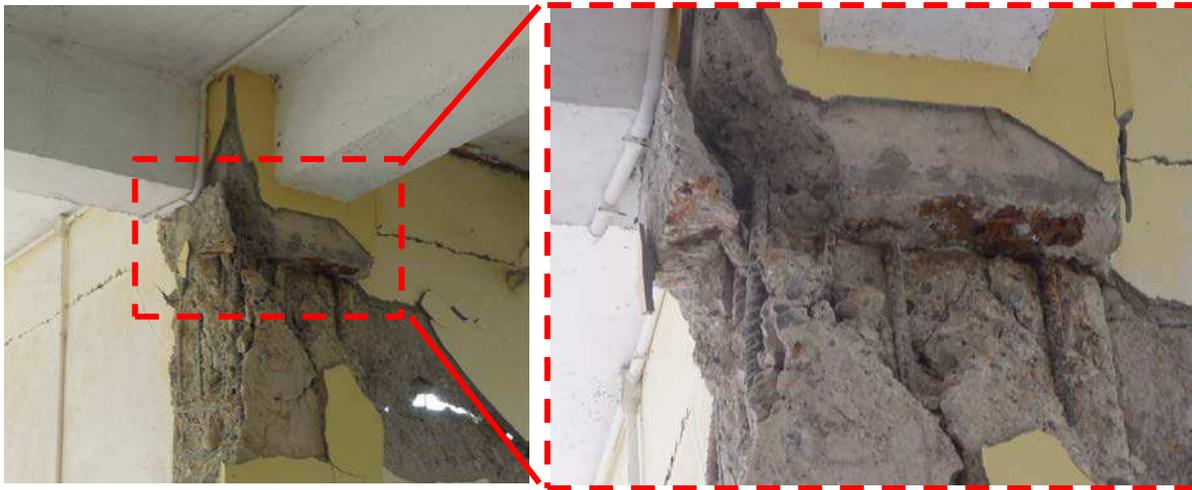
a. Poorly constructed beam-column joints

This failure was observed in a government office. The failure was characterized by spalling and bursting of construction joints where the rebar was spliced, near the beam-column connections (Figure 11). Poor design and detailing may contribute to this failure, considering that the location of the construction joint is close to a highly stressed region of the building. Poor construction quality, indicated by debris in the connection, may also worsen the quality of the joint.

Figure 11. Construction joint failure (photo: Muhammad Riyansyah)

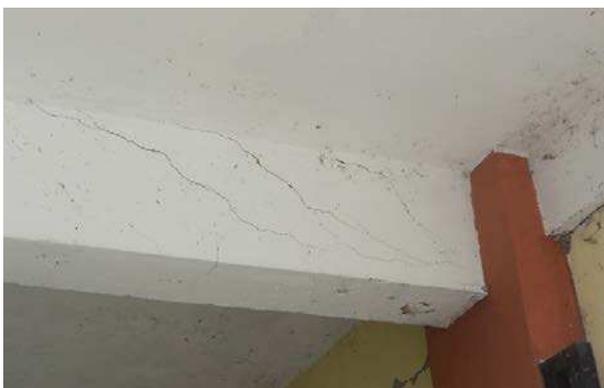
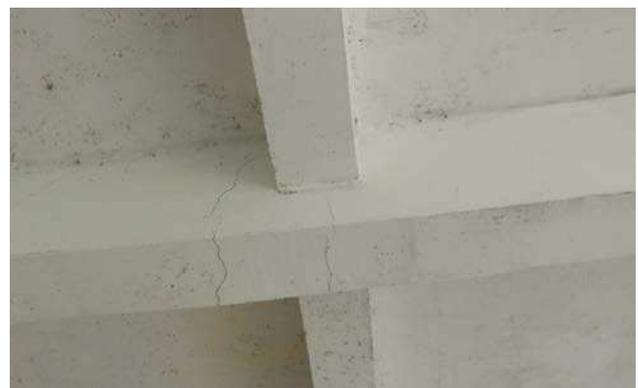
b. Shear and flexural cracks on beams

This failure was observed in the same government building in which the construction joint failed. Shear and flexural cracks (Figure 12) were observed on some beams located at the basement of that building. However, shear cracks were observed more often during the survey. Poor detailing may be the main factor that caused these cracks.

Figure 12. Shear and flexural cracks on a beam (photos: Muhammad Riyansyah).

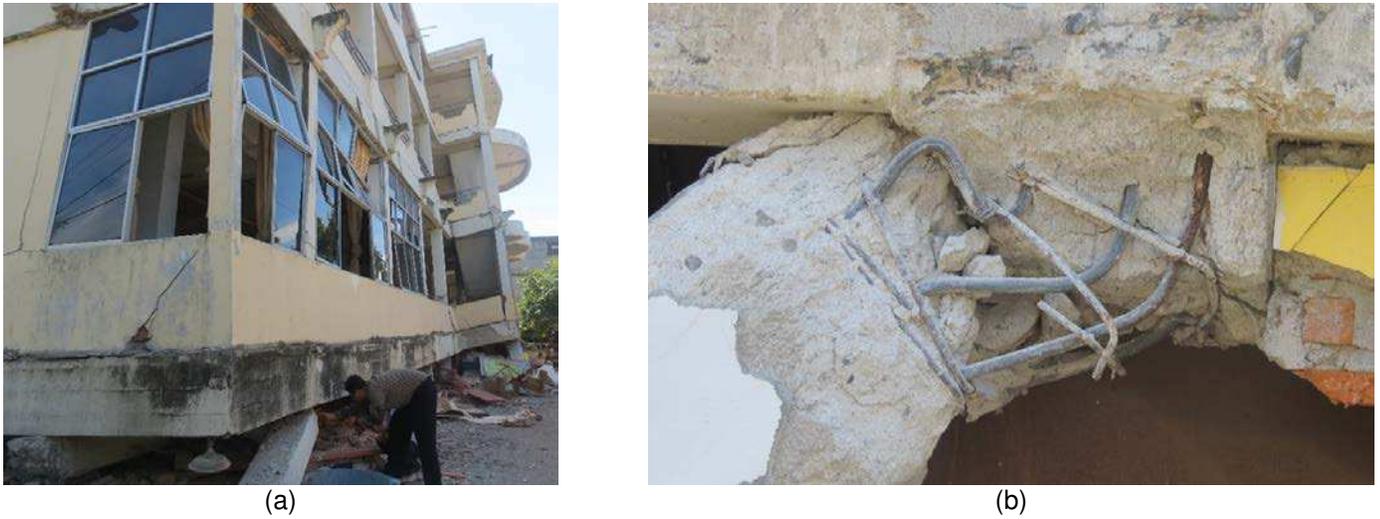
c. Soft-story mechanism

Soft-story mechanism was observed on a four-story college building and a mosque. The first story of the school building collapsed as shown in Figure 13. Based on the observation, poor structural configuration and reinforcement

detailing contributed to this failure. It is also important to note that the rebar used in most collapsed buildings was undeformed rebar, both as longitudinal and transverse reinforcements.

Figure 13. Soft story collapse on a low-rise reinforced concrete building: (a) overview of collapse, (b) mangled rebar due to collapse (photos: Puskim Kemenpupera).

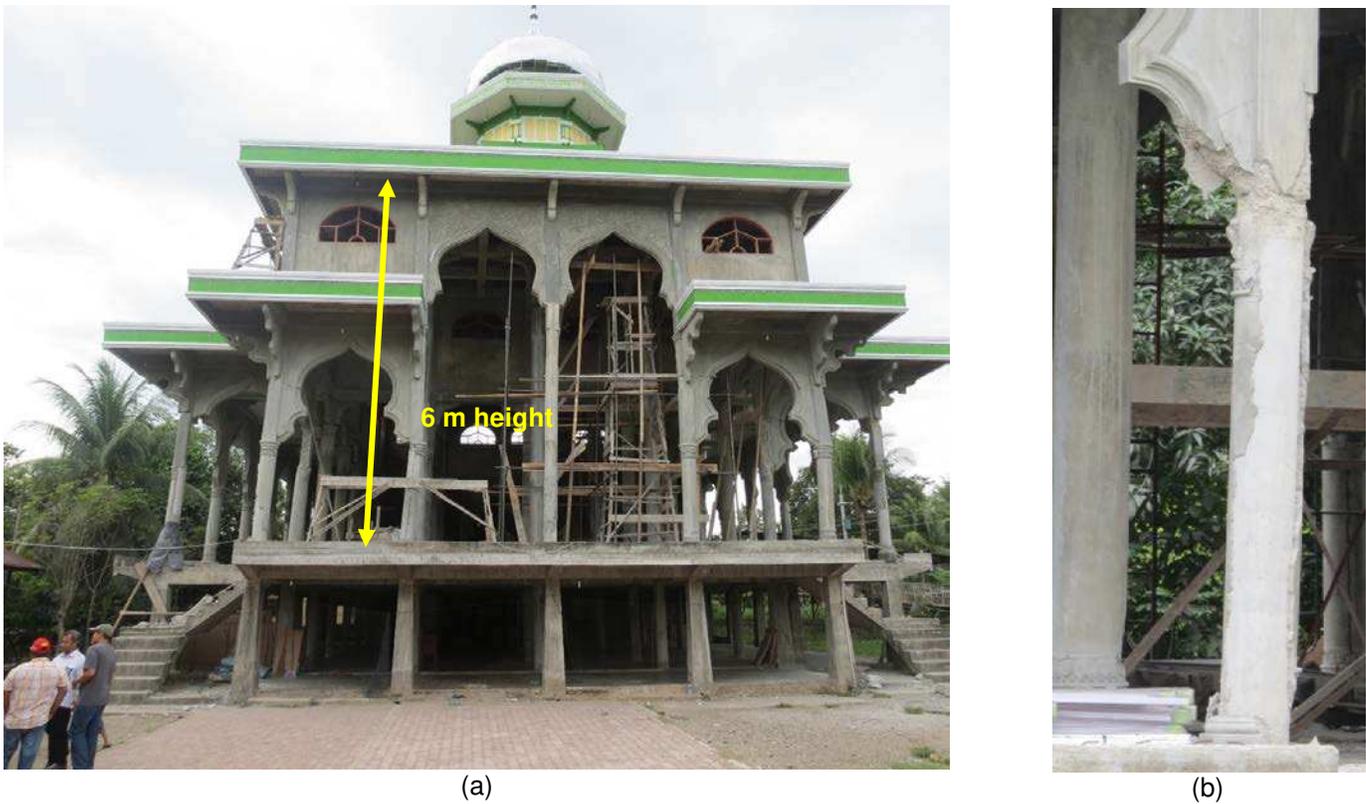
On the other hand, significant structural damage was observed on slender columns of a mosque (Figure 14). At the time of the earthquake, the mosque was still under construction with remaining nonstructural and decoration work. The columns on the second floor were approximately 6 m tall and they had to support a large mass of the roof and the dome. More detailed investigations showed that the slender column was poorly detailed with inadequate longitudinal reinforcement, largely spaced transverse reinforcement, and the use of undeformed rebar (Figure 15).

Figure 14. Soft story effect on a mosque structure: (a) overview of mosque with scale, (b) damage to column (photos: Puskim Kemenpupera).

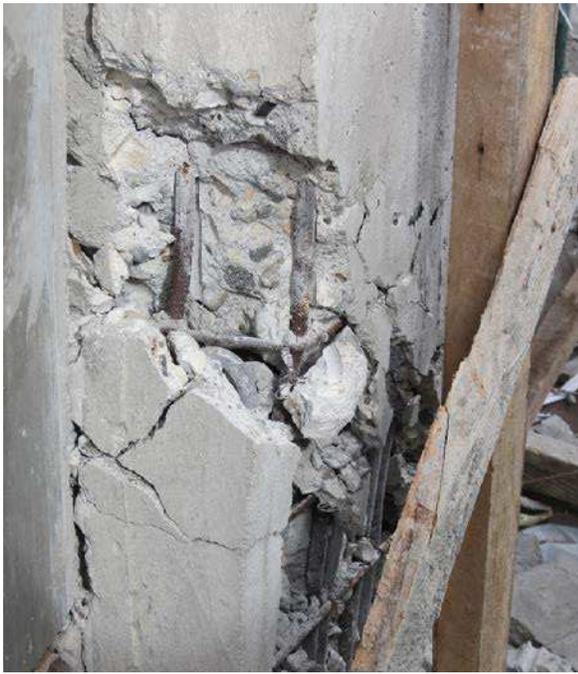
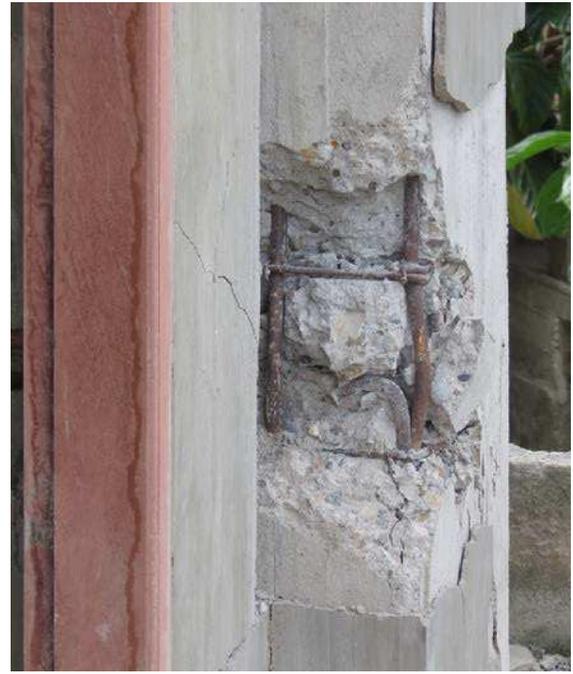
Figure 15. Poor detailing on the slender columns (a) and (b) (photos: Puskim Kemenpuera).

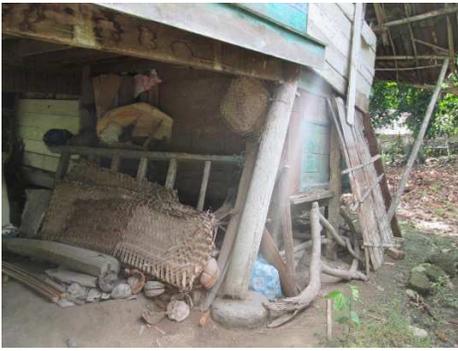
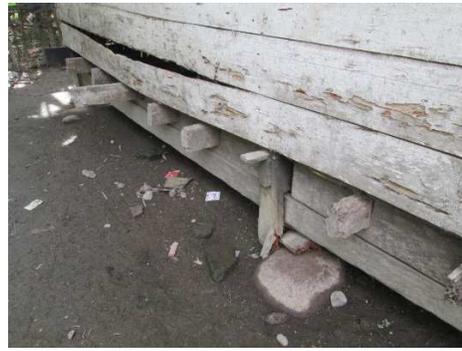
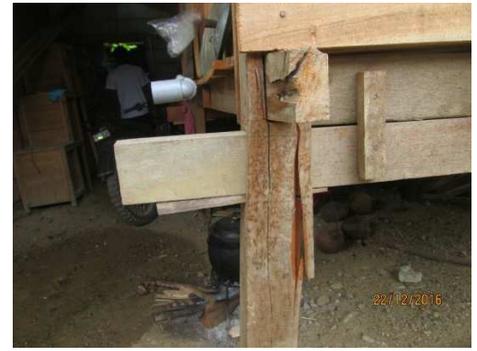
For raised timber houses, the lower level posts were typically unbraced and poorly connected to the foundation, in some cases simply resting on top of stone bases. This led to the observed racking of the lower level, sliding the posts off the bases or unseating of the posts, and in some cases, fracture of the posts due to large drift in the earthquake (Figure 17).

Figure 17. Damage to raised timber frame houses: (a) racking/drift of posts, (b) posts shifted off base, and (c) fractured posts (photos: Build Change).

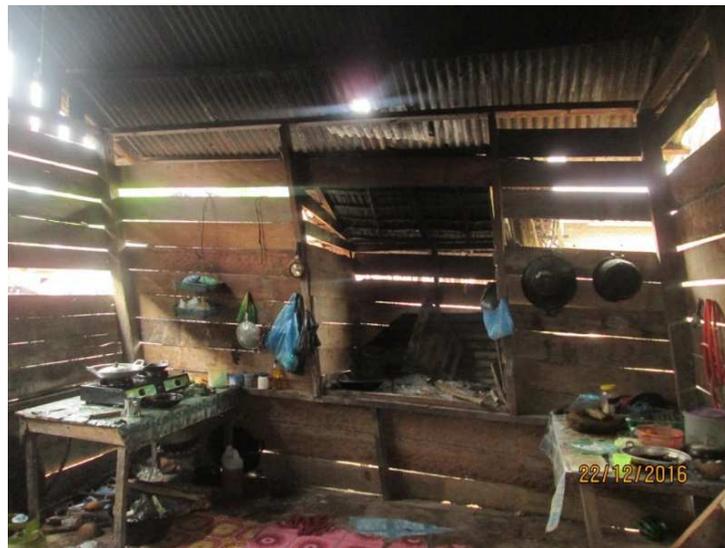
Both raised and on-grade timber buildings typically used horizontal planks as the wall covering. Although horizontal sheathing can provide lateral strength to walls, in many cases the planks did not seem to be sufficiently nailed to the wall framing, or were placed with large gaps between them, reducing the effectiveness of the planks to contribute to lateral strength and stiffness. In some of these cases, racking of the walls and permanent story drift were observed (Figure 18).

Figure 18. Racking in timber framed house (photo: Build Change).

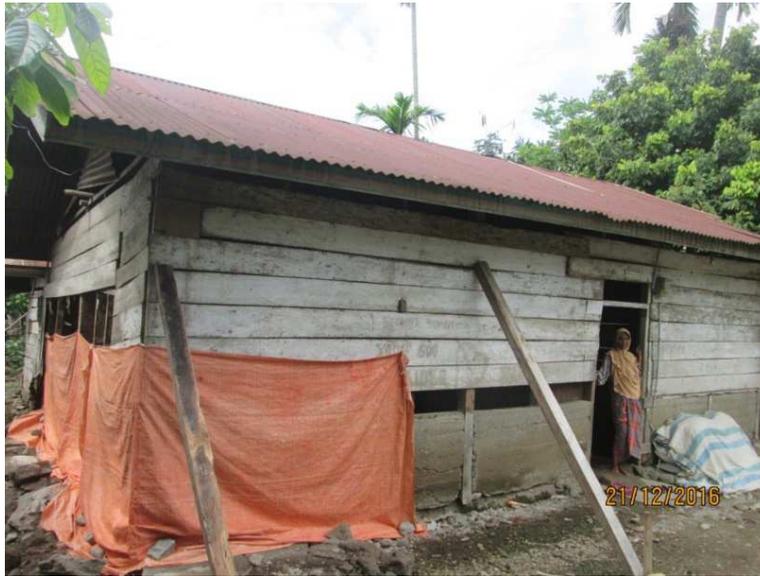
Damage specific to the on-grade timber houses with masonry skirt walls consisted of cracking or partial collapse of the skirt wall – typically due to poor construction of the wall and low quality materials, inadequate connection to the timber posts, and/or a lack of top beam on the skirt wall (Figure 19).

Figure 19. On-grade timber house with partially collapsed skirt wall (covered by tarp) (photo: Build Change).

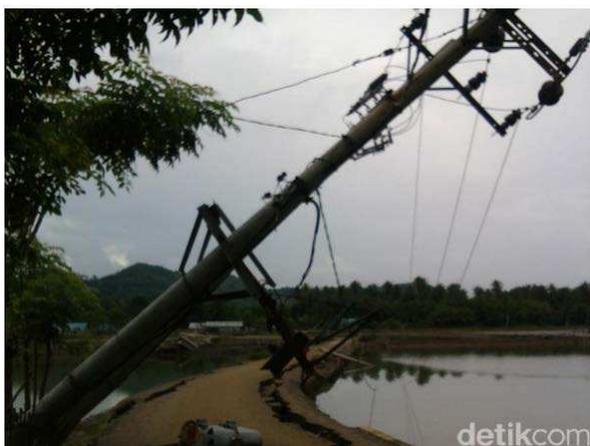
The earthquake interrupted the electrical distribution to over 40,000 customers. It was recorded that 84 transformers, electrical cable lines, and more than 100 low-voltage and medium-voltage electrical poles (Figure 20) were damaged during the earthquake. The damage was concentrated at electrical facilities located in Samalanga, Meureudu, and Beureunun regions. The power distributed in the Samalanga region is 500 kW, and the power distributed in Meureudu and Beureunun is around 6 MW (Jati 2016).² Some retrofit and reconstruction measures, such as reconnecting the broken electrical cable and reconstruction of low-voltage pole, were conducted by the state electricity company (Perusahaan Listrik Negara, or PLN) to recover the interruption. The electrical distribution was 50% recovered within two days after the earthquake, and it was completely recovered within four days after the earthquake (PLN 2017).³

Figure 20. (a) Damage on electrical poles during the Aceh earthquake, (b) recovery efforts conducted by the State Electricity Company (photos: Augustinus 2016).⁴

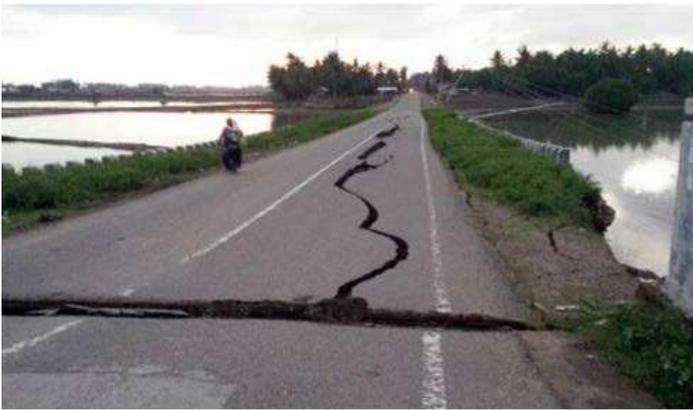
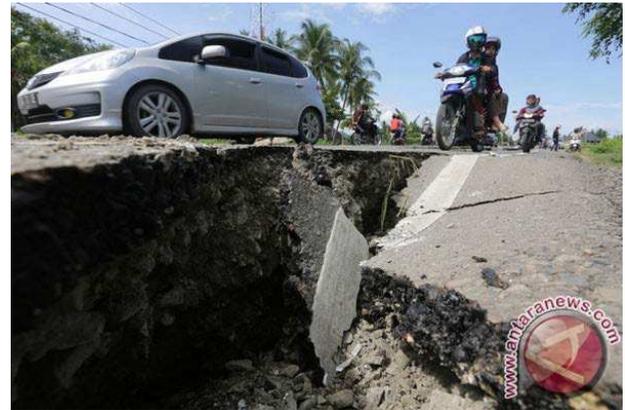
Figure 22 shows the cracks on some roads in the Pidie Jaya region. This earthquake also caused damage on some bridges in Pidie Jaya, Pidie and Bireuen. Efforts were carried out to repair and reconstruct the damaged road and bridges. In addition, the Aceh International Airport located around 100 km to the west of the epicenter was unaffected by the earthquake.⁷

Figure 22. Cracks on the road in the Pidie Jaya region (photos: (a) Siswoyo 2016⁹, (b) Antara News 2016).¹⁰

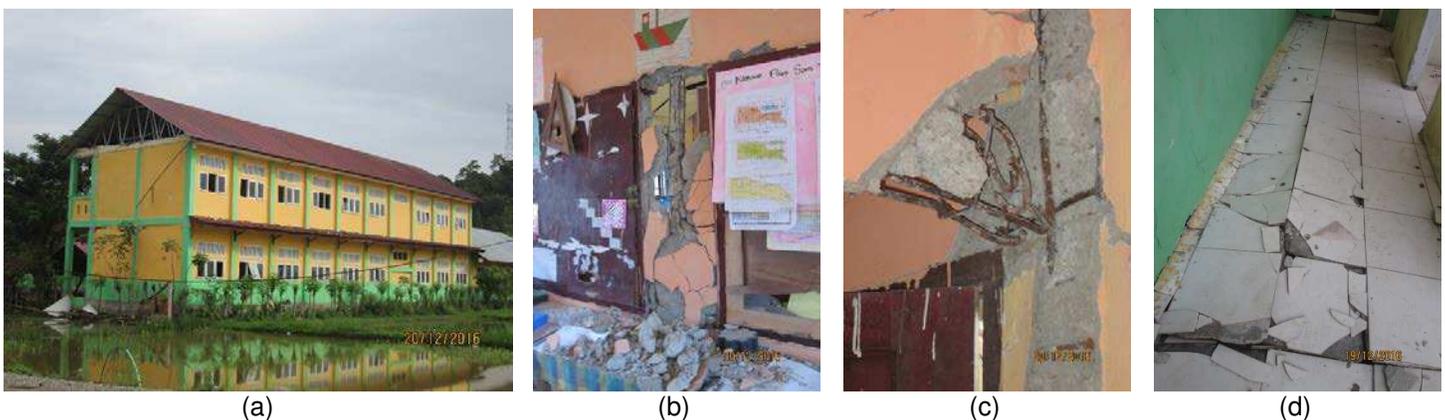
There was relatively little variation in type, configuration, and construction quality of the observed schools. All observed buildings have many windows along the front and back of the building. Although the amount of damage varied, there were commonalities observed, such as the collapse of tall and thin unreinforced masonry walls, the collapse of gable end walls, wall cracks at the openings, cracking through wall piers and at longitudinal cracking at the wall-column interface, damage to beams at column faces, and cracks on the floor due to poor compaction of backfill (Figure 23). The quality of concrete was generally low due to the use of poor quality materials, such as round gravel (Figure 24). Inadequate concrete cover was also observed, exposing corroded reinforcing bars and spalled. It was observed that undeformed rebars were used for both main longitudinal and transverse reinforcement. The use of deformed bars was not observed in the schools visited. Damage to the dropped ceiling systems was also common, where ceiling panels and framing fell into the classroom, possibly due to insufficient support and bracing of the system to the building structure (Figure 25).

Figure 23. Damages at School Buildings: (a) gable wall collapse, (b) failure of wall pier and column, (c) failure of beam to column connection, (d) cracking in the floor slab (photos: Build Change).

Damage can be reduced and collapse can be prevented in the common school building typologies observed with some simple improvements to the observed structures. Construction quality must be improved, such as by providing adequate rebar cover and improved connections between masonry and reinforced concrete elements (toothing or bed joint dowels). Better quality materials, such as concrete, deformed reinforcing bars, and stronger bricks are needed. In addition, adequate detailing of the reinforcement in beam and column joints is required, so that proper bar hooks and lap splices are provided.

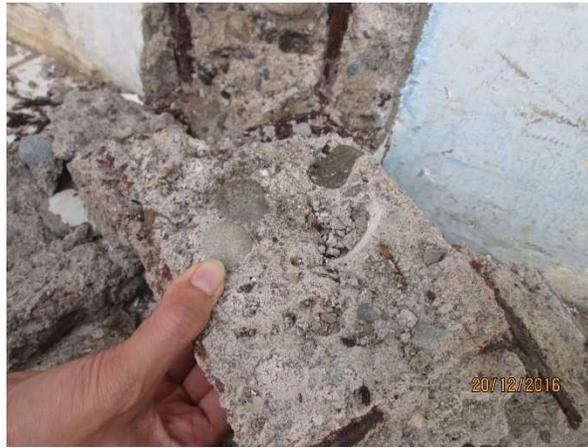
Figure 24. Low quality concrete in school column (photo: Build Change).

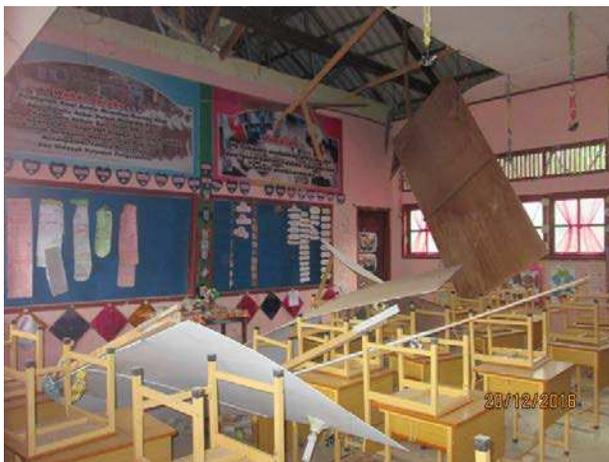
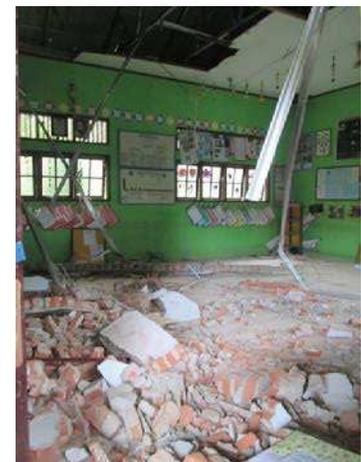
Figure 25. Ceiling damage in classroom buildings (photos: Build Change).

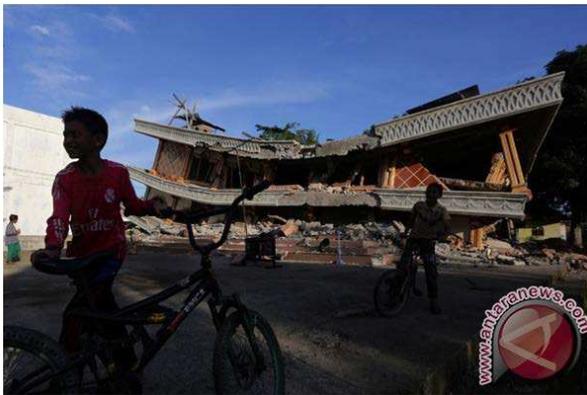
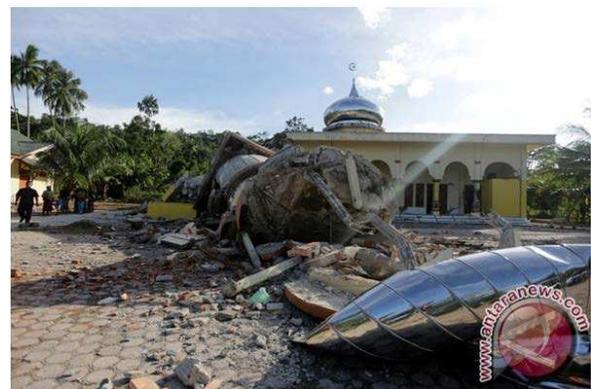
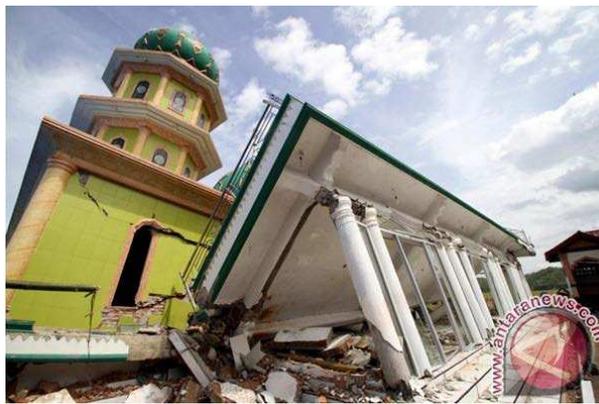
Figure 27. Damage to mosques: a) Damaged mosque at Meuko Kuthang, b) Damage of Mosque Jami Nur Abdullah at Lueng Putu, c) Damage of Mosque Baitul Muttaqin (photos: Antara News, 2016).^{14, 15, 16}
