## 1. INTRODUCTION

On February 19, 2015 Build Change, represented by Juan Caballero, Lizzie Blaisdell and Hector Romero Toro, visited six schools in the districts of San Marcos (four) and Quetzaltenango (two), Guatemala. See Figure 1 for the location of the two cities in Guatemala. These schools had been damaged by either or both of the recent earthquakes in the area; some had or were receiving some form of repair while others still remain in their post-earthquake damaged state. The intent was not to perform detailed evaluations of each school during the visit, but instead to get a better understanding of the schools each municipality may need technical assistance with, what their construction styles are and what the potential deficiencies may be.

This report summarizes the observations made at each of the visited schools, identified potential deficiencies as well as possible retrofit strategies.

**3. SCHOOL OBSERVATIONS**  
**3.1 INSTITUTO NACIONAL DE EDUCACION BASICA EXPERIMENTAL**  
**“MARIA CRISTINA BARRIOS”**

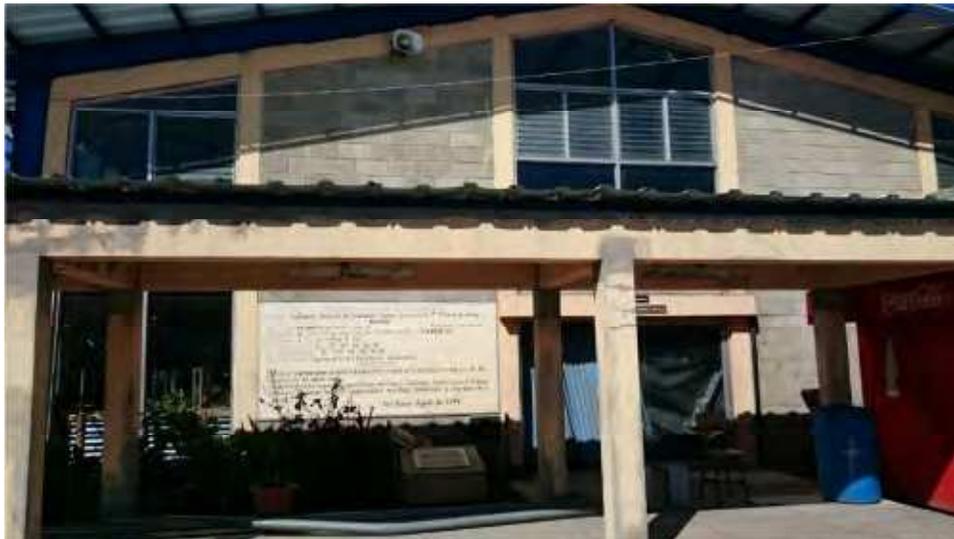
Figure 2 – Administrative two-story building

The school is located on flat land. It consists of multiple independent confined masonry buildings. The administration building is two-stories tall (Figure 2) and the classroom buildings are one-story (Figure 3). The roofs are composed of light-gage steel tubes or channels with corrugated metal roofing. There is a reinforced canopy structure covering the walkways between buildings; this is shown in both Figures 2 and 3.

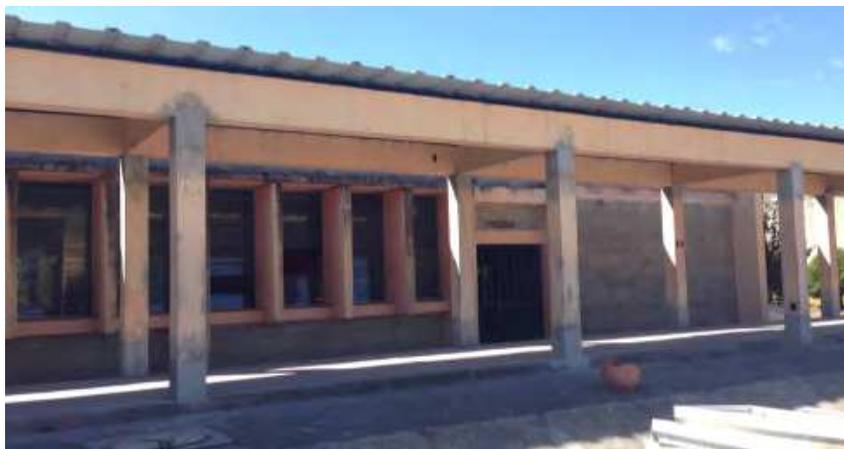
Figure 3 – School Building with covered walkway in front

- Lack of longitudinal shear walls – The longitudinal classroom walls consisted primarily of window openings which reduces the lateral strength and stiffness of the building in the longitudinal direction (Figures 5 and 6). In some buildings a solid wall panel was provided at the end of the longitudinal wall elevation (Figure 3) but in other buildings it was not.

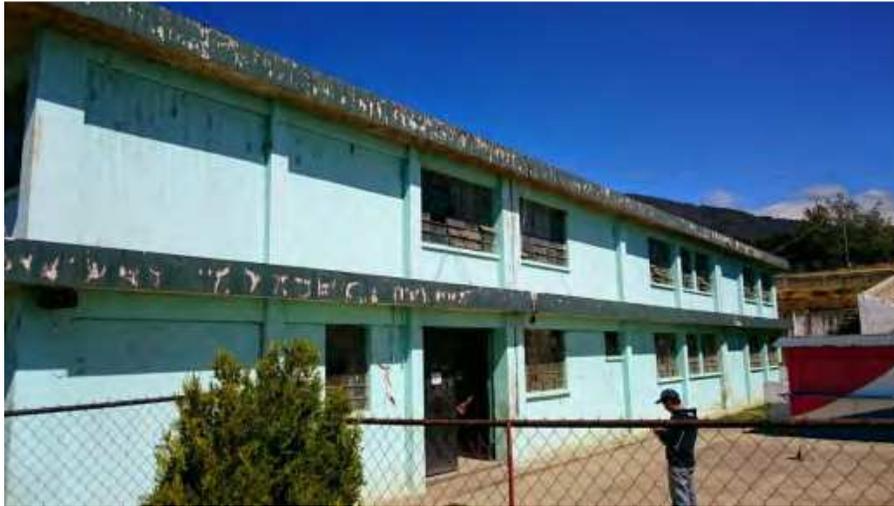
Figure 9 – Concrete moment frame building

The school is located on a gently sloping site. It consists of three independent two-story reinforced concrete frames with masonry infill buildings (Figure 9) and one two-story confined masonry building (Figure 10). The concrete frame buildings are arranged in a U-shape around central courtyard and have a small seismic gap separation between each other (Figure 11). There also appeared to be a foam material around the perimeter and separating the infill panels from the frame structure. These buildings have concrete slab roofs. The confined masonry building has a light weight roof framed with shallow steel trusses. The stair bay at one end appeared to be an independent adjacent structure.

The confined masonry building had been repaired and appeared to have thicker wall piers between windows. The reinforced concrete frame buildings were still in their damaged state. According to the school principal, the first earthquake caused cracking at the infill panel edges (Figure 12) and the subsequent earthquake led to some cracking in beams and columns (Figure 13). In some cases, the cracking around the panel edges is significant and could lead to out-of-plane failures of the wall panel in future shaking.

- Non-ductile concrete frame - Due to the age of the concrete moment frame structure, it is likely that ductile frame detailing specified in more recent building codes is not present. In the absence of the wall panels to help resist lateral loads, the frame would likely have significant damage and drift – potentially failure.

- Unconfined wall panels – With the joint material separating the infill from the frame, the panel is largely disconnected and unconfined. Unconfined wall panels can more easily suffer out-of-plane failures.
- Inadequate seismic joint – The small joint between buildings could result in pounding damage in future earthquakes. However, given that the floor and roof slabs align, significant damage due to this pounding, such as a collapse, may be less likely.

- Replace infills strategically to create solid shear wall panels.
- Connect or confine all masonry infills.
- Provide reinforced concrete overlays to the shear walls as needed for increased strength.
- Effectively repair damaged beams or columns.

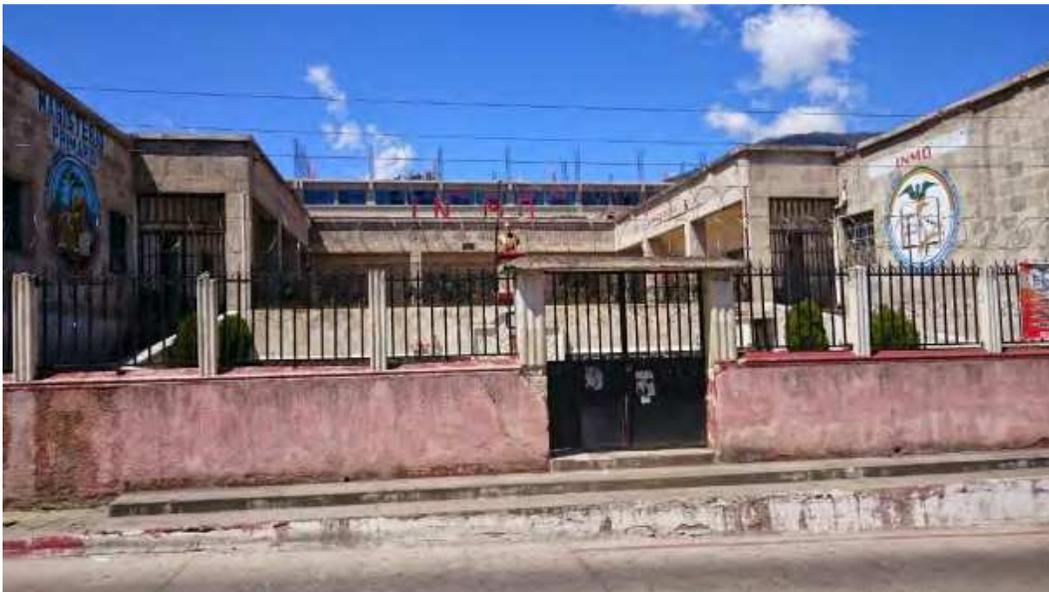
Figure 16 – Front of INMO – one story partially confined buildings

There are three main structure types at the INMO school. The school site is gently sloped, with about a one-story height difference from one side of the campus to the other. There are one-story unreinforced or partially confined older buildings (Figure 16), a three-story confined masonry structure (Figure 17) and a new two-story confined masonry building (Figure 18). The older portion of the build also houses a two-story tall auditorium space (Figure 19). The one-story structures typically have light-weight roofs. The two and three story structures have concrete slab roofs.

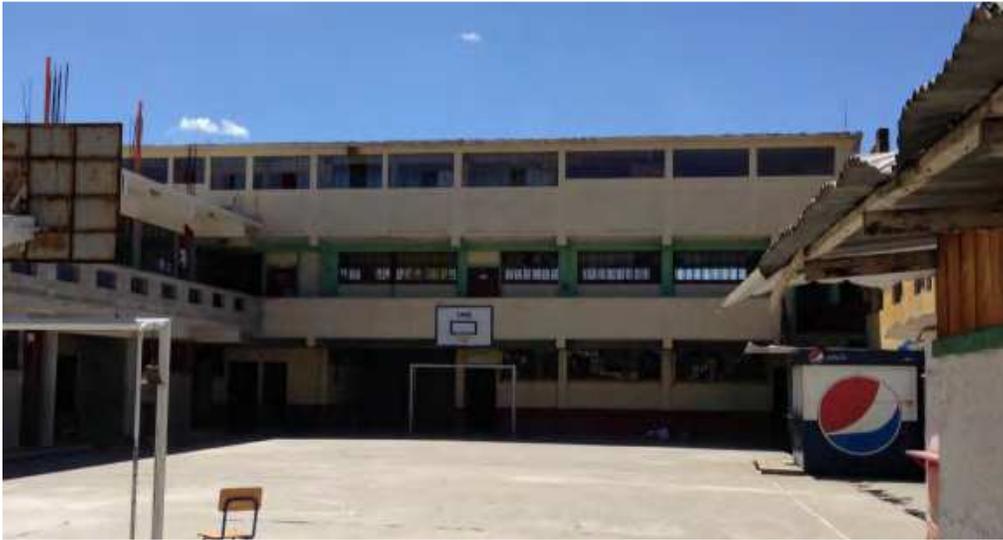
Figure 17 – Three-story confined masonry building

The two-story building was constructed after the earthquake and therefore had no damage. The one-story structures had some in-plane (Figure 20) cracking and out-of-plane failures (Figure 21) of the unreinforced masonry walls. The three-story structure was more heavily damaged and only partially repaired. There was evidence of wall failures in shear (Figure 22), short column failures (Figure 23) (which had been repaired by adding a new column next to the failed column (Figure 24)), and residual out-of-plane wall movement (Figure 25).

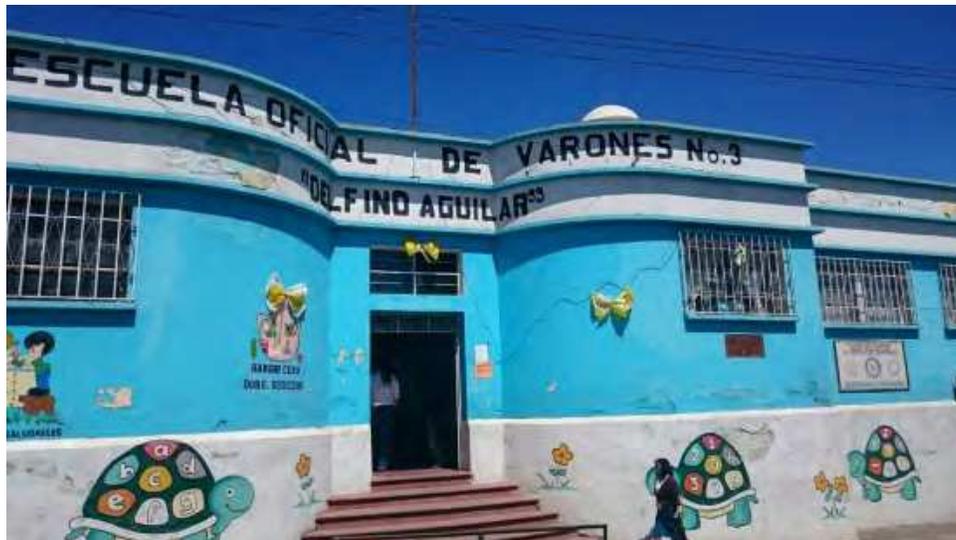
Figure 26 – Front of school

The building is single-story and U-shaped around a central courtyard (Figure 26 and 27). There is a taller portion at the front of the building (Figure 28). The building has a concrete roof at the entrance, and light-weight roof at the classroom wings. The walls appeared to be partially confined brick masonry walls. The site is essentially flat.

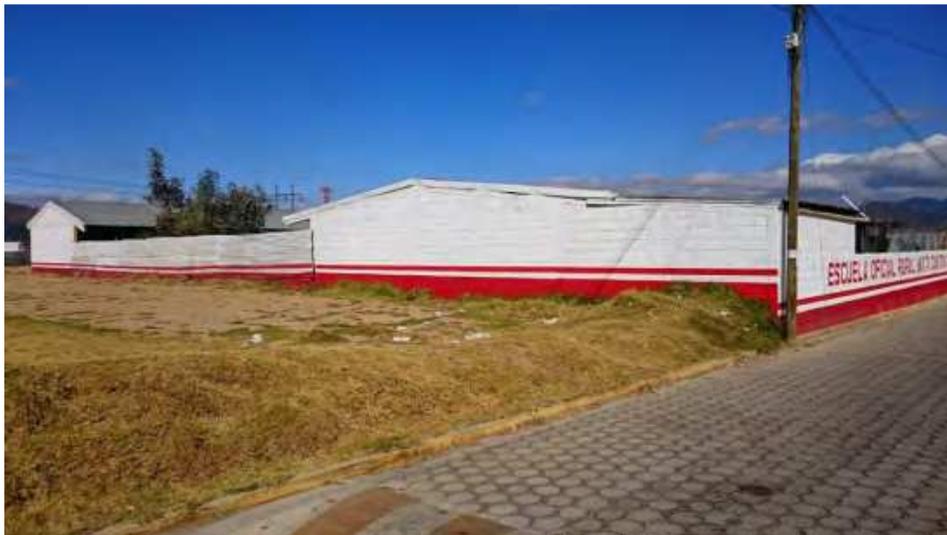
Figure 34 – Low-rise confined masonry school buildings.

This school had multiple one-story confined masonry buildings with light weight roofs (Figure 34). The masonry gable end walls were low-rise and typically had confining elements (Figure 35). The site was flat. The building was only observable from the exterior during the visit.
