**Build Change, AARGI, and EERI
Earthquake Reconnaissance Report:
M6.5 Pidie Jaya Earthquake,
Aceh, Indonesia on December 7, 2016**

Lizzie Blaisdell Collins (*Build Change*), Elwahyudi (*Build Change*), Edwin Lim, Mediatrich Triani Novianingsih (*Build Change*), Muhammad Riyansyah (*AARGI*), and Hartanto Wibowo (*Iowa State University*)

May 2017

A product of the EERI Learning From Earthquakes Program

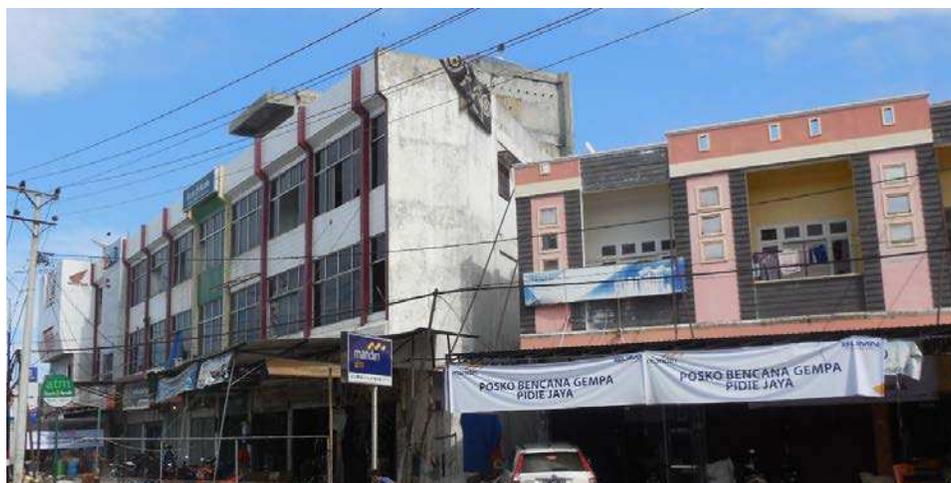
The practice of confined masonry construction is also common on low-rise shop-houses (typically 2-3 stories). This type of building is typically used for commercial purpose on the first story and residential purpose on the upper stories. Similar to the typical damage observed in other past earthquakes, the failure was attributed to soft-story mechanism of the first floor where wide opening exists as the main entrance for the commercial activity. Figure 7 shows the typical shop-houses in the affected area. BNPB reported that 78 shop-houses (BNPB, 2016) were damaged due to the earthquake. This number is relatively small compared to the number of damaged residential houses of 19,000 (BNPB, 2016). In the survey, the AARGI team observed that additional floor constructed above the existing building might have caused the damage because there were similar unmodified shop-houses located near the damaged ones that were unaffected by the earthquake. This additional floor changed the dynamic characteristics of the structures, and there was a great possibility that the existing structural components were not designed to carry that additional load (Figure 8).

Figure 7. Typical shop-house in the affected area (photo: Muhammad Riyansyah).

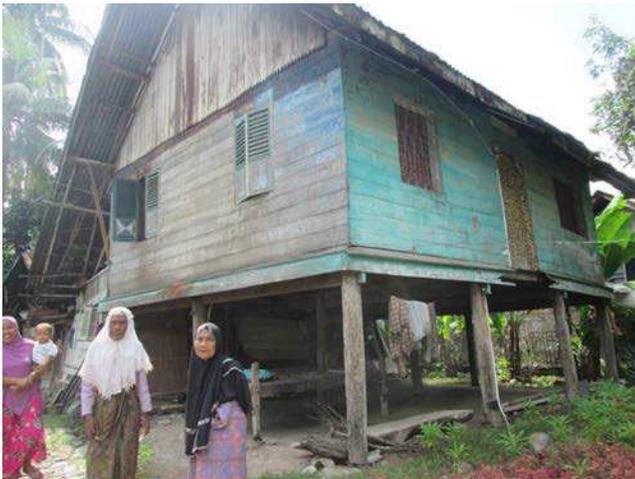
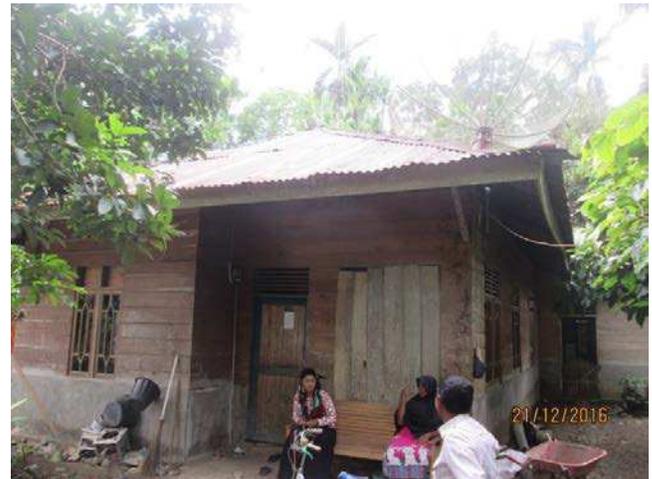
Several different types of wood frame buildings were observed. Wood-framed houses were either raised up on posts above grade (from 30 cm to 2.5 m), or were built directly on grade (Figure 16). In houses built directly on grade, a portion of the wall below the windowsill level was typically constructed using masonry or a cement-sand mortar (called skirt wall). Timber wall and roof framing were then subsequently placed above this skirt wall. One timber school building was observed following this style of construction.

Figure 16. Timber frame houses: (a) raised, (b) on-grade with skirt wall (photos: Build Change).

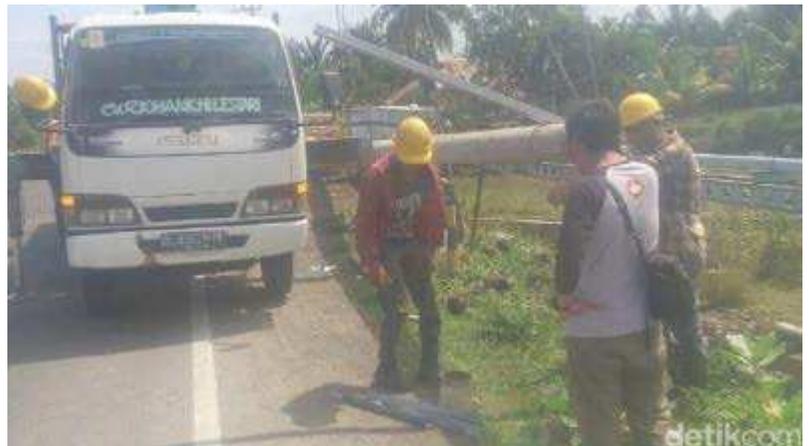
The earthquake interrupted the electrical distribution to over 40,000 customers. It was recorded that 84 transformers, electrical cable lines, and more than 100 low-voltage and medium-voltage electrical poles (Figure 20) were damaged during the earthquake. The damage was concentrated at electrical facilities located in Samalanga, Meureudu, and Beureunun regions. The power distributed in the Samalanga region is 500 kW, and the power distributed in Meureudu and Beureunun is around 6 MW (Jati 2016).² Some retrofit and reconstruction measures, such as reconnecting the broken electrical cable and reconstruction of low-voltage pole, were conducted by the state electricity company (Perusahaan Listrik Negara, or PLN) to recover the interruption. The electrical distribution was 50% recovered within two days after the earthquake, and it was completely recovered within four days after the earthquake (PLN 2017).³

Figure 20. (a) Damage on electrical poles during the Aceh earthquake, (b) recovery efforts conducted by the State Electricity Company (photos: Augustinus 2016).⁴

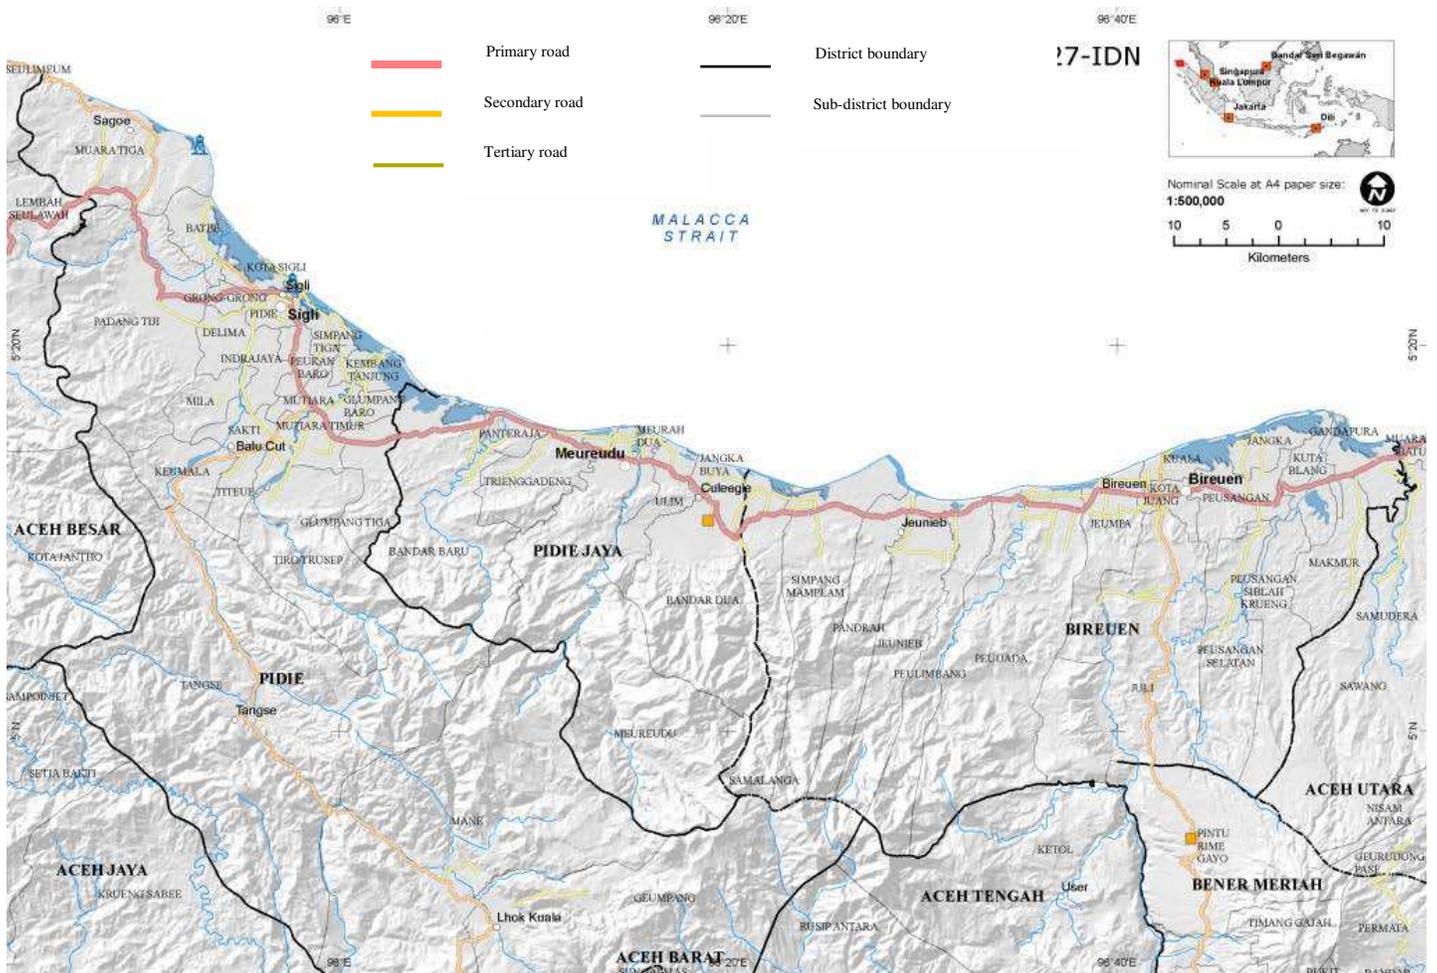
Figure 21 shows the road network in the affected area. All the primary roads from Banda Aceh – Aceh Besar – Pidie – Pidie Jaya were functional although localized cracks were spotted at some locations between Pidie and Pidie Jaya (AHA Centre 2016).⁶

Figure 21. Road network in the affected region (figure: World Food Programme 2016).⁸

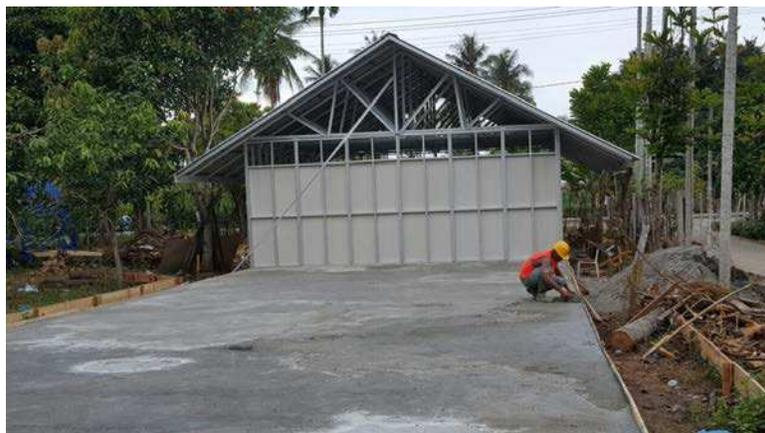
Collapsed school buildings were almost completely cleared or demolished by the time of the visit. The school reconstruction and renovation will be overseen by the Ministry of Public Works (PU). PU built temporary building structures (Figure 26) for the 24 schools that were badly damaged, targeted to be completed by end of February. The budget and planning for reconstruction of permanent schools were still under confirmation and waiting for approval. Once started, the expected time frame for reconstruction is 6-12 months.

Figure 26. Construction of temporary school (photo: Puskim Kemenpupera).¹²

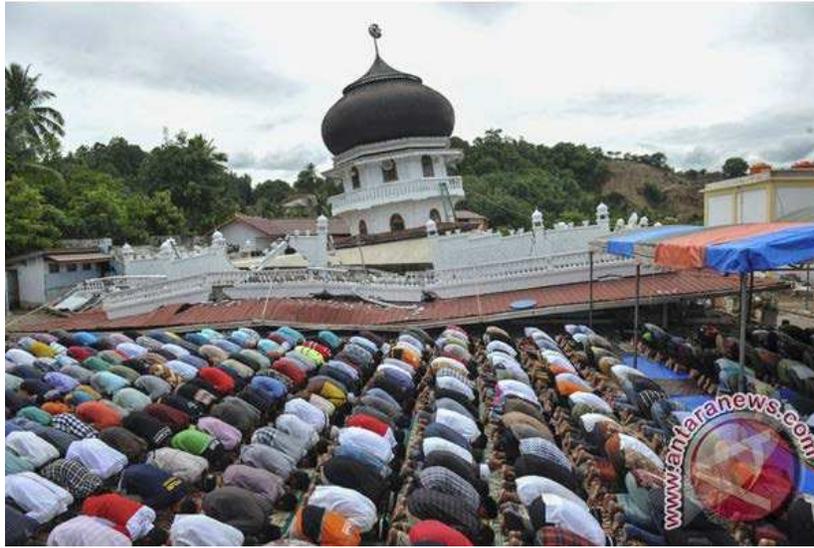
Reconstruction of the mosques was one of the main priorities for the government. Figure 28 shows the community gathered beside the collapsed central mosque to conduct their routine Friday prayer.

Figure 28. Friday prayer near the central mosque at Pidie Jaya following the earthquake (photo: Antara News, 2016).¹⁷

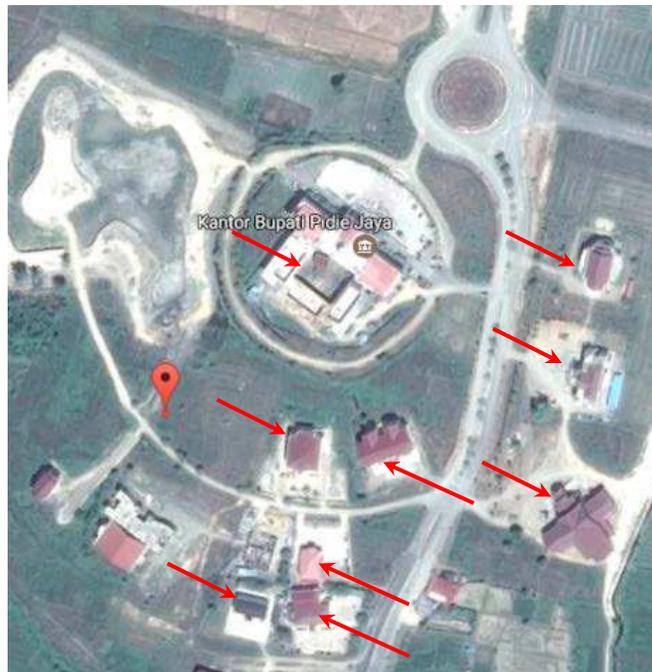
The AARGI team visited eight government offices that are located adjacent to one another (Figure 29). The building typology of the government offices is reinforced concrete frame with masonry infill. Most of the buildings performed well during the earthquake, with notable non-structural damage to the infill wall, ceiling, and roofing material. Some sections in the buildings were advised to be closed for access until further investigations were conducted to clean the falling hazard from the damaged nonstructural components. One building experienced structural damage to the columns and beams at the basement floor. This building was labeled unsafe, and further investigations, as well as retrofit design and construction, were later conducted.

Figure 29. Location of surveyed government offices.
