LONG-TERM CHANGE IN CONSTRUCTION PRACTICE THROUGH POST-EARTHQUAKE RECONSTRUCTIONS

Post-disaster housing reconstruction projects present an ideal opportunity to create a lasting change in construction practice, so that houses built during and after technical and financial assistance are disaster-resistant. Recent observations from the 1993 Killari, 1999 Chamoli, and 2001 Bhuj, India earthquake reconstructions indicate that, in the absence of building standard enforcement, a combination of technical, economic, and social criteria must be met in order for new houses to be earthquake-resistant and occupied, and for earthquake-resistant construction technologies to be permanently adopted by individual builders and homeowners. The most sustainable building programs are those that use locally available materials and skills and produce a structure that is both culturally accepted and competitive in cost with common (but vulnerable) building methods. This paper proposes criteria for long-term change in single-family housing construction practice that can be applied to post-disaster reconstruction and new housing construction programs in less developed countries where continued enforcement

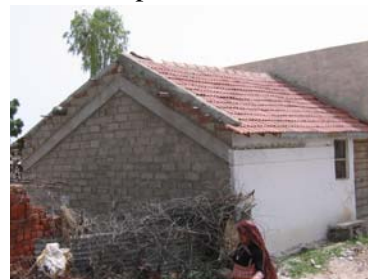
- Although Bhuj guidelines cover a gable roof with tiles on timber rafters and purlins, they are vague in their guidance on the proper connection between the gable band and the roof structure. Most of the pitched-roof, owner-built houses surveyed in the Bhuj area visit had omitted the gable band (Fig. 1).
- In the Chamoli reconstruction guidance, design of an RC slab roof was omitted completely; yet most owners who built new houses opted for an RC slab.
- Masonry confined by RC columns and beams was prevalent in all three affected areas for houses built by wealthier owners.¹ Although the Indian Seismic Standards address reinforced concrete detailing, no guidance was produced for this type of construction. Many design and construction quality issues were observed (e.g., Fig. 2).

Fig. 1. Missing gable band, seismic belt added (Bhuj EQ)

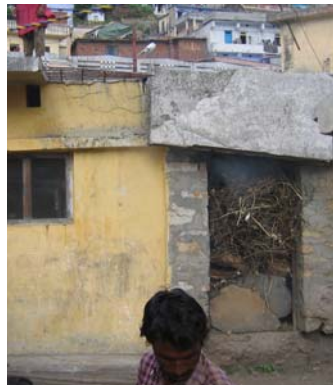
The house should be durable, or capable of withstanding earthquakes, heavy rainfall and other natural conditions throughout its useful life. For example, Fig. 3 shows an RC slab roof overhang that partially collapsed shortly after construction. A precast plank and joist system used in the Chamoli reconstruction was widely reported as prone to leakage and cracks (Fig 4).

Fig. 3. Partially collapsed, newly built RC slab roof (Chamoli EQ)

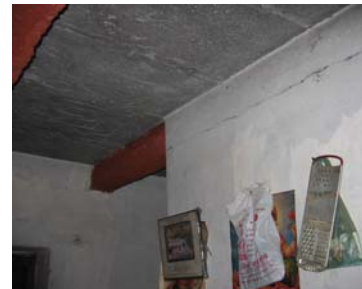
Fig. 4. Precast plank and joist system with crack along joist-wall interface, leakage between planks (Chamoli EQ)

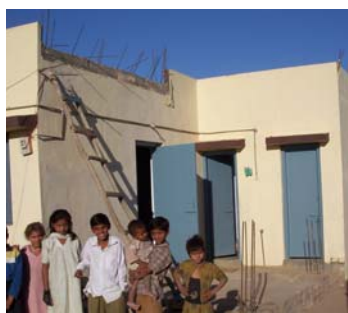
- If a structure is built with a flat roof, it is likely that a second story will be added as the family expands (Fig. 5). Many foundations for one-story structures with flat roofs were not designed to carry the load imposed by a second story.

Fig. 5. Preparations for a second story. Toilet on right. (Bhui EO)

windows, some homeowners blocked in openings and created others in more preferable locations. Not a single homeowner interviewed expressed a preference for locating the toilet and bathing facilities inside the main living area; all residents prefer a separate structure with a separate entrance (Fig. 5). Those toilets that were built inside the structure were used as storage spaces. Provisions for shelves, fan fixtures, and traditional or religious features were also absent in some of the donor-built houses.

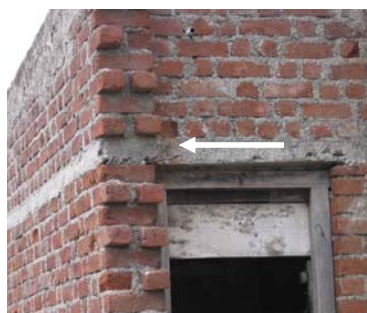
- If a structure is built from prefabricated components produced in distant cities, it is difficult for rural residents to obtain additional components for expansion or repair. Similarly, prefabricated structures are typically unable to support the weight of a second story built with locally available, heavy masonry materials.
- Where reinforced concrete columns or bands are used, it is common to extend the steel beyond the existing structure in anticipation of an extension (Fig. 6). The steel rebar was often of insufficient length to provide adequate overlap. Also, the condition of the rebar deteriorates over time as it is exposed to moisture.
- Continuing the masonry beyond a corner so that the proper bond can be taken up when the owner extends (Fig. 6), although somewhat common, was not always done in the preferred location (Fig. 7).

Fig. 6. Masonry bond for extension; short rebar length (Killari EO)

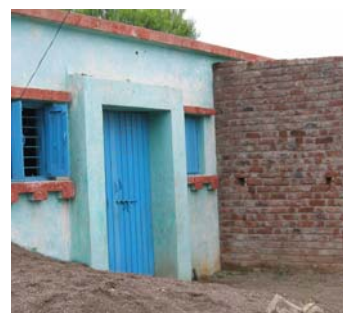
Fig. 7. Extension without proper connection (Killari EO)

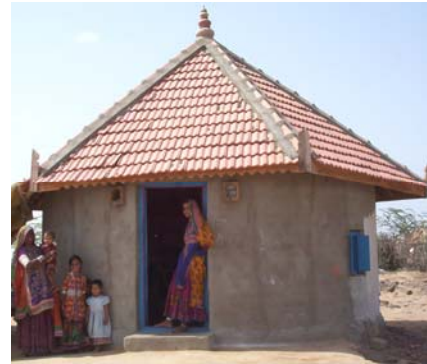
Fig. 8. Circular, stabilized earth-walled structure with pitched roof, appropriate for hot climate (Bhuj EQ)

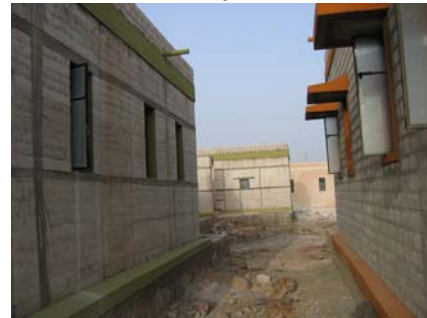
Fig. 9. Houses built early in the program without lintels (left), windows with substantial lintels built later (Bhuj EQ)

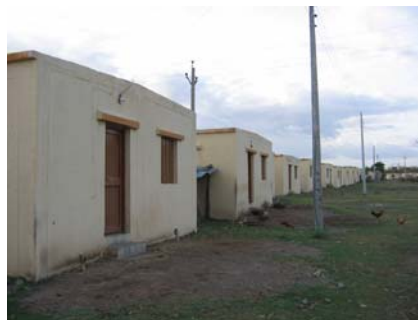
In the case of relocated houses and villages, the layout of individual plots and the organization of the village should be appropriate to local culture and lifestyle. If the homeowners keep animals, an enclosed plot is necessary. The character of the place should be preserved or modernized, depending on the preferences of the people. Water and electricity should be available in the village. Relocating a village away from a water source could result in a village that is predominantly unoccupied (Fig. 10).

Fig. 10. Relocated village that is predominantly unoccupied due to lack of water (Killari EQ)

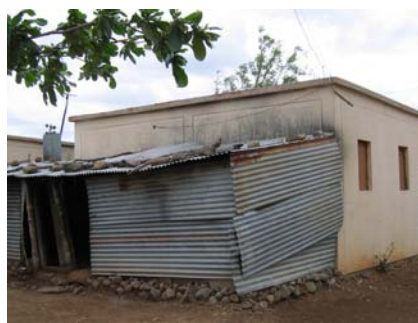
Finally, people must trust that the structure is earthquake-resistant and safe to live in. In some of the most severely affected villages in the Killari area, residents were not sleeping inside their house, even 10 years after the earthquake. Instead, they had built extensions with corrugated galvanized iron (CGI) sheets (Fig. 11). In some Bhuj-area villages, residents are waiting one year before sleeping inside the house so that the house can be tested by aftershocks. Villagers reported that they had observed poor construction practices, or had not been involved in the construction.

Fig. 11. CGI sheet extension (Killari EQ)
